## **Reuse of Old State Buildings In Cabeceiras de Basto**

**Keywords:** state buildings, old primary schools, rangers' houses, railway station, rehabilitation, reuse.

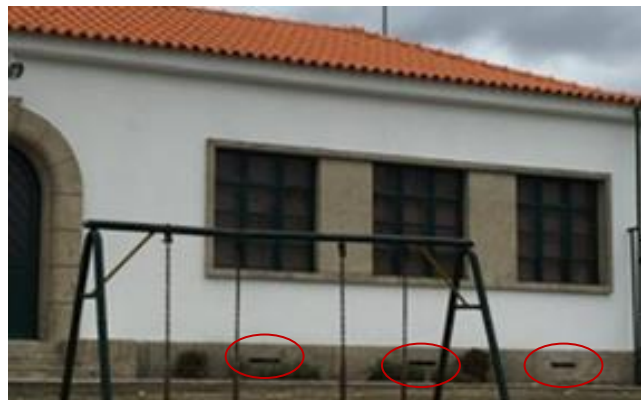
The construction solutions used to built all these buildings are the same. With respect to the exterior appearance of these buildings, it is generally found that there is a lower row of stone masonry along its contour, in which small openings can be seen. These openings allow the natural ventilation of the wooden floor, Figure 5. This solution prevent the direct contact of the wood with the soil, in order to guarantee its greater durability, avoiding, for example, rotting due to contact with the soil moisture and the attack of the wood by xylophages agents.

Figura 5 - Natural ventilation openings.

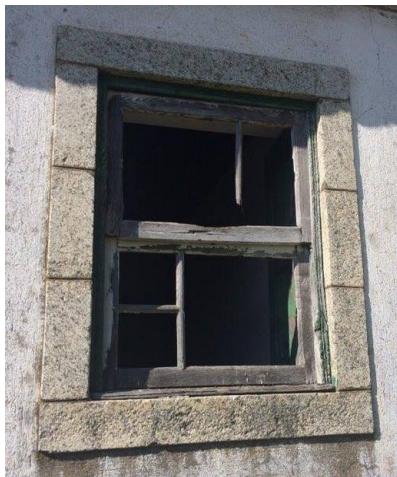
b) Rotting of the elements of wood

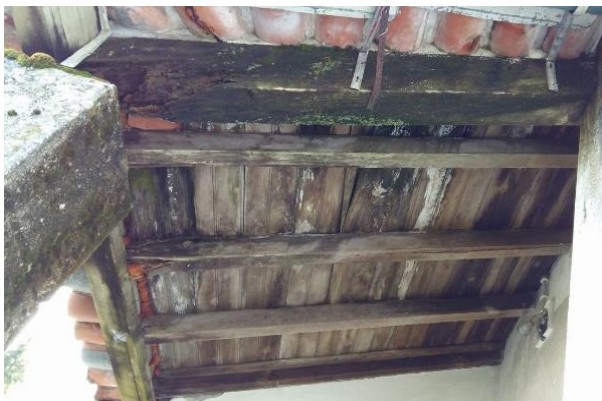
d) Rotting of the timber elements

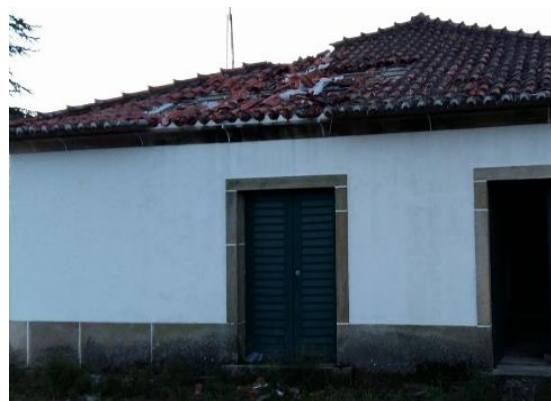
e) Absence and cracking of ceramic tiles
