ICOSADOS 2018

**8th INTERNATIONAL CONFERENCE
ON SAFETY AND DURABILITY OF STRUCTURES**
23rd-25th of May 2018

Proceedings

8th International Conference on Safety and Durability of Structures

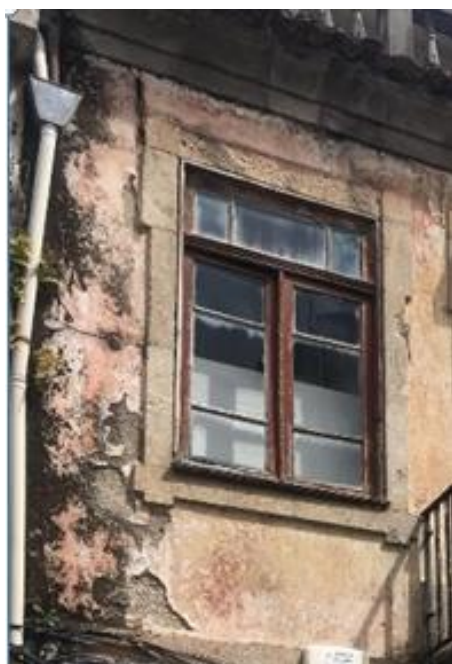
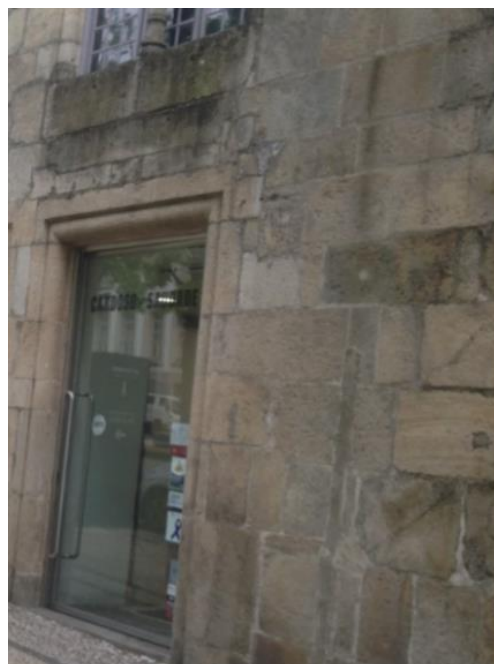
In Figure 6 the facades of two buildings are presented. On the left photo the facade of the building presents dampness, mould and peeling paint. On the right photo the granite is cracked, and there is dampness under the window sill.

Figure 6 - Facades with dampness, mould, peeled paint and cracks.

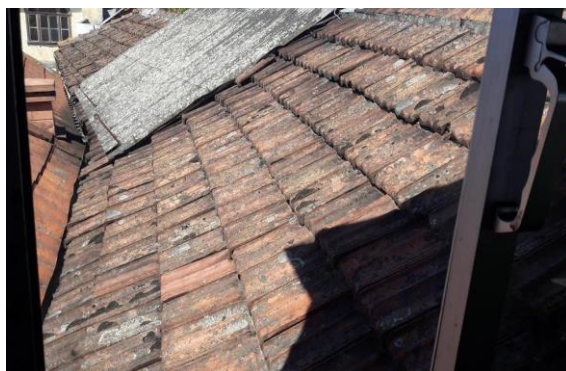
The access of the exterior of the pitched roofs, in most of the buildings was difficult, even so it was found the presence of parasitic vegetation in the ceramic tiles in 6 cases and deterioration of the drainage system in 5 cases. A damaged roof is shown in Figure 7.

Figure 7 - Parasitic vegetation in Marseille tiles

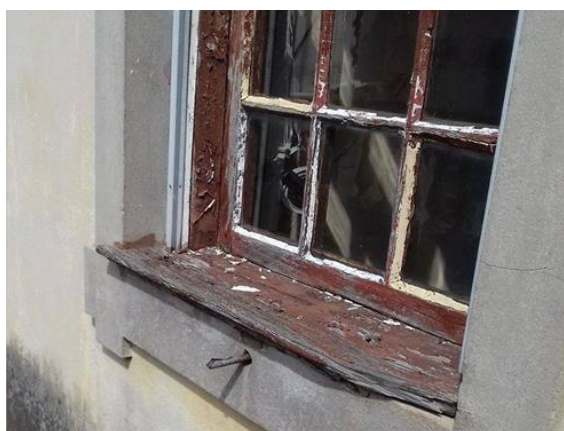
Several pathologies in a window can be observed in Figure 9, such as degradation of the paint and of the timber frame, broken glass and window sill.

Figure 9 - Pathologies in window.

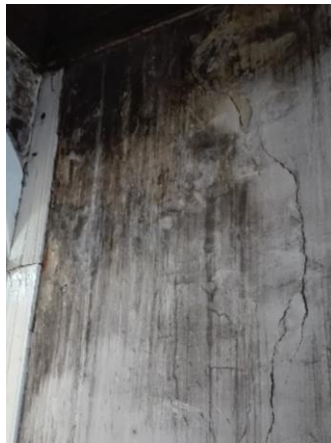
The more frequent pathologies in interior walls are crack, in 15 of the studied buildings and dampness in 10 of them. In the example presented in Figure 10, the main cause of these pathologies

can be water infiltration, due to roof or drainage problems. The dampness leads to the appearance of mould and possibly to the cracking and blistering of the mortar.

Figure 10 - Dampness, cracks and mould in an interior wall

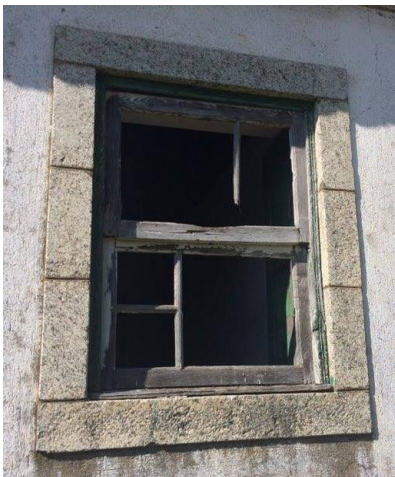
b) Rotting of the elements of wood

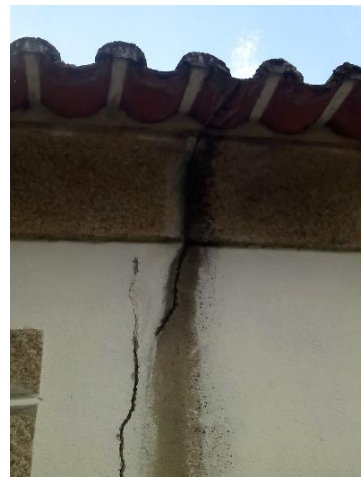
c) Moss and painting's degradation

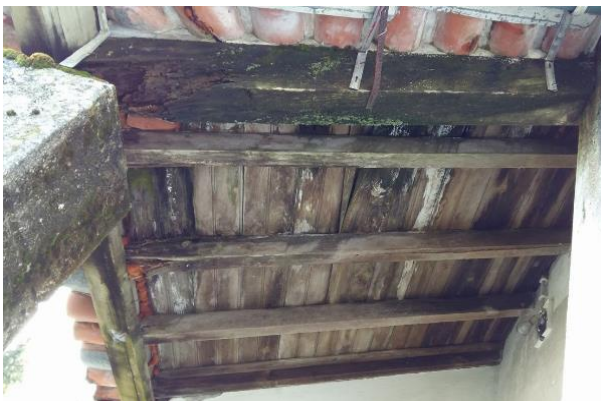
d) Rotting of the timber elements

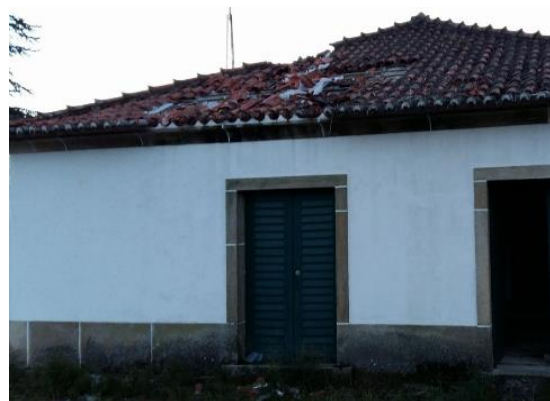
e) Absence and cracking of ceramic tiles

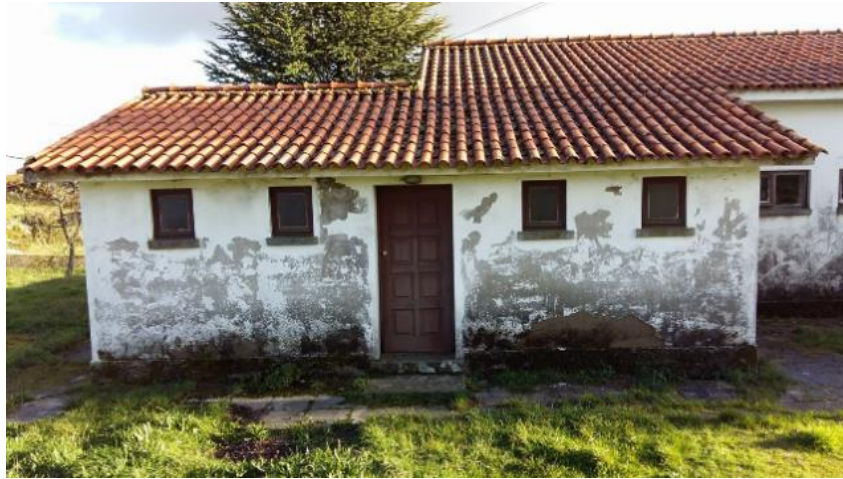
Figure 7 - Moss and painting's degradation
