## DEFECT ANALYSIS OF REINFORCED CONCRETE SLABS FOR EARTH DAM SLOPE PROTECTION

**Raimondas Sadzevicius, Feliksas Mikuckis, Dainius Ramukevicius**  
Lithuanian University of Agriculture,  
Department of Building Constructions  
raimondas.sadzevicius@lzuu.lt; sk@lzuu.lt; dainius.ramukevicius@lzuu.lt

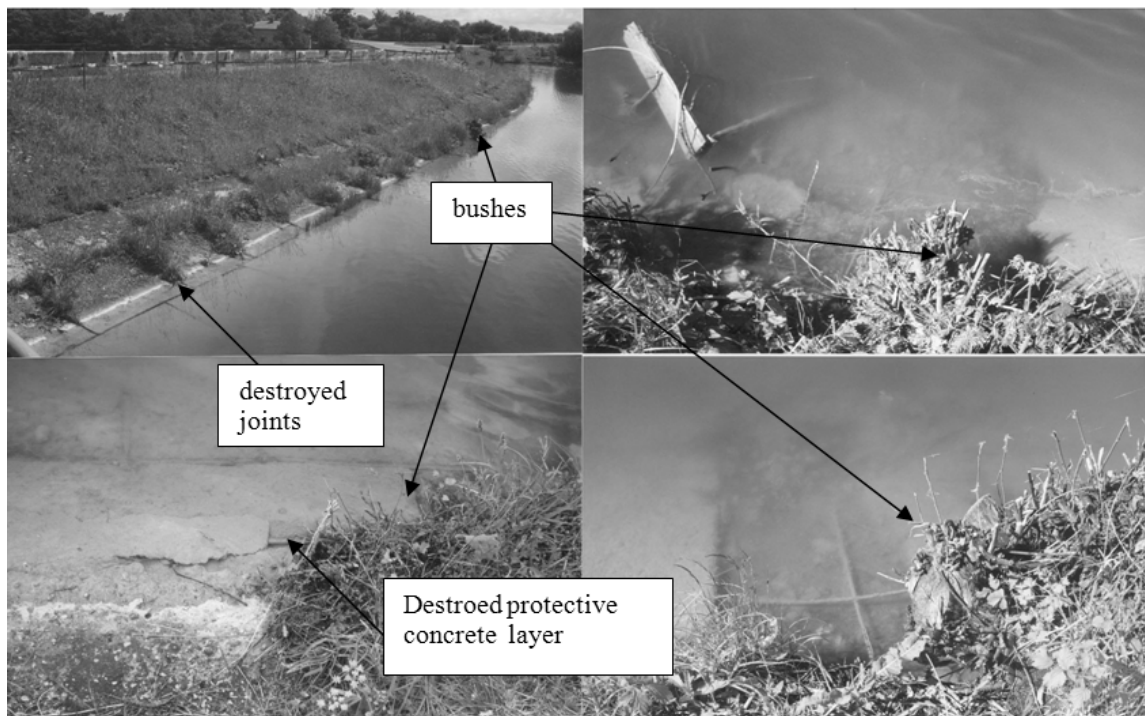
7.	Gailiusiai 29	9.1±0.4	Damaged joints, damaged surfaces	Weak concrete, damaged joints	5.9
8.	Grauze III 37	7.1±0.4	Damaged joints, damaged surfaces, corrosion of reinforcement and concrete,	Weak concrete, damaged joints by grass, bushes roots, thin covering layer	7.7

The actual service life of the oldest hydraulic structure is 89 years and 10 years of the last one. The strongest concrete with average compressive strength 29.3 MPa was established in the slabs of Ukmerge HS, the weakest one – 5.5 MPa in the structures of Kruostas HPS. The surfaces of the structures manufactured with stronger concrete were less damaged. Concrete is affected in the changing water level most intensively. Pittings on the surface of the structures proceed rapidly in this zone. The possibility of damages of the covering layer is created by sufficient conditions for corrosion of reinforcement. Defects are in progress then joints are damaged (25 from 30 investigated objects). The bad exploited joints were damaged by the weeds or even scrubs. Roots of scrubs can break reinforced concrete strengthening slabs (Fig.1).

**Figure 1.** Destroyed joints by grass, bushes roots in Grauze pond (Kaunas district).

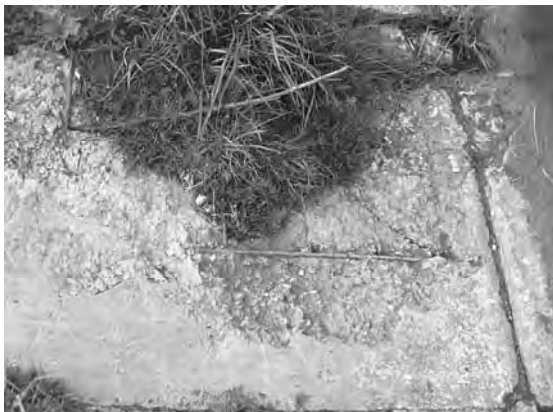
5.	Ageniskis 32	11.8±0.4	Damaged joints	Damaged joints by grass	7.0
6.	Gulbinai 32	24.3±1.2	Damaged joints, corrosion of reinforcement and concrete,	Damaged joints by grass	7.0
<b>Kaunas district</b>

several reasons of forming pitting, but the main is–erosion of concrete by the influence of frost cycles (Fig. 2). The surface of the structures on the changing water level zone is touched by ice, swimming solids or sediments (especially gravel) abrasive impact. After establishment, which impact is the most actual in separate ponds, there is a need to explore in more detail the pitting appearance reasons. Other reasons of concrete erosion presented in literature, for instance, cavitations, are less found in our researched structures, because in the researched ponds, the water flow pulsation speeds are small (<2m/s).

**Figure 2.** Erosion of surface on concrete slabs (Ageniskis pond) by influence of frost cycles.
