# Auguliena Manor over the centuries

Jānis Zilgalvis, Riga Technical University

**Abstract.** Auguliena Manor (*Roseneck*) [3] which in German is also called *Augul* and in Latvian translated as Ozolmuiža or Auguļi [2] is located in the Beļava Parish of the District of Gulbene, approximately 15 km away from Gulbene on the bank of Lake Auguliena. The building of Auguliena Manor, along with other individual buildings, is included in the national list of protected cultural monuments. The Manor building consists of the manor house, two servants' houses, a house for servants with a household building, the feedlot wing, a threshing barn and a few other buildings. The history of the Manor is associated with the family of von Transehe–Rosenecks. Over the years the building has changed a little but the planning structure has survived. Renovations in the Manor take place, so its study is topical.

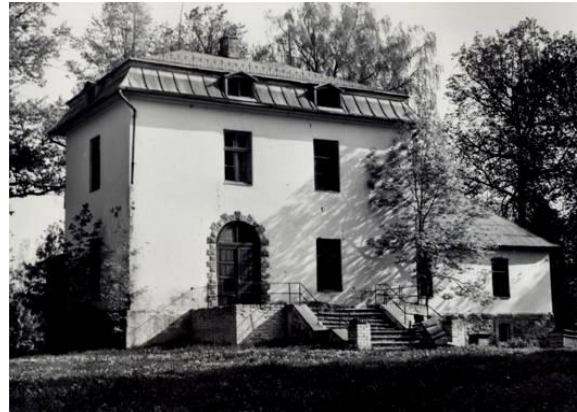
Fig. 1. The manor house of the Auguliena estate (photo 1978)  
[Source: State Inspection for Heritage Protection,  
Monument Documentation Center]

In the Soviet time, there was a club in the manor house and in 1983 the building was no longer used. It was exposed to danger long before. As shown in the photos of 1978, the windows are still in place, the main entrance door as well, the roof is in a good condition and the ironwork over the ridge as well. The terrace railings are partially collapsed at the main

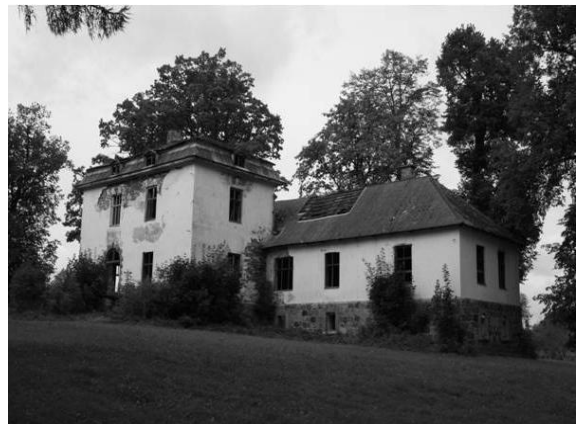
Fig. 2. The manor house of the Auguliena estate  
[Source: photo by the author, 2009]

entrance and in front of the facade once grew shrubs and the trees give evidence of leaving everything to the mercy of fate. In 1994, the building was still relatively in a good technical condition but threats to the further existence is already felt [12]. Today, the building is in a very poor technical condition. The cover of the intermediate floors is falling in, the windows and doors are partly lost, the exterior stucco crumbles, in the state of the collapse there is the terrace at the main entrance.

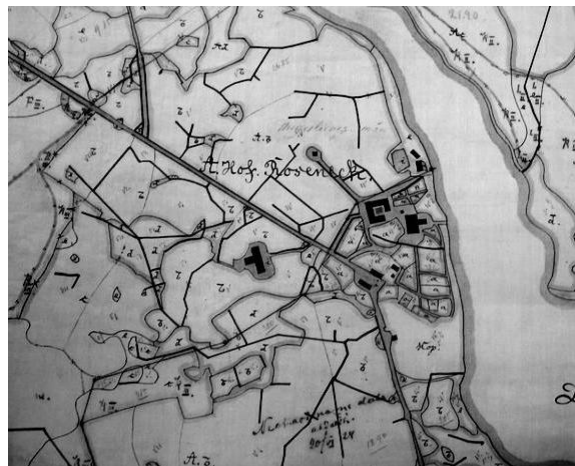
Fig. 5. The land plan of Auguliena Manor. A copy of 1907 from the plan of 1873-1874 [Source: Latvian State Historical Archives]

The oldest information available so far about the Manor building is drawn from the land plan of 1873-1874 which was copied in 1907 [6]. It appears that the center of the Manor consisted of eleven larger or smaller buildings and structures. The largest of them is the feedlot of which is left only one wing, the manor house, two servants' houses, the servants' and household buildings behind the manor house and more away, a building standing on the other side of the road-a threshing barn.

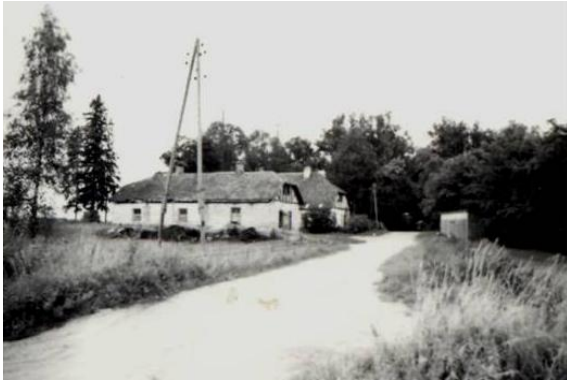
Fig. 6. The servants' houses (photo 1975)  
[Source: State Inspection for Heritage Protection.  
Monument Documentation Center]

In the center of Auguliena Manor, there are two servants' houses built almost parallel to each other. Entering the Manor, a view opens to one of them-a one-storey-building which is covered by a gabled ridged roof with partly sloped ends. The building, in the end pediments of which there is used a timber frame and infill structure, is built of red bricks. Already in 1994, this building was in a poor technical condition but when the author of this article surveyed the Manor building in the 1980s, it was still partly inhabited. In the course of time, due to the critical technical condition the building had to be dismantled and in 2000-2003 it was rebuilt maintaining the original shape. This building, in comparison with the second one parallel to the servant's house, was newer. This is evidenced by many clumsy volume spatial structure peculiarities, mysterious earthiness of the roof forms and other particularities. The second servants' house was a little different from the first one. It was built as a corner-jointed building, then lined with red bricks, which, in turn, were plastered. This building was heavier, with a gabled ridged roof with sloped ends-the

highest, namely, the volume form was more classic and antique for the Manours' building. After the end facade, the pediments were also made in the timber frame and infill structure. In 1994, this building still had six pane windows, tile roofs but in the 1980s it was still inhabited. Just as the first servants' house, this building, not repaired, gradually went to rack and ruin and in the 2000s-2007s there was no choice but to dismantle the building and build a new one similar to its original appearance. Now both servants' houses are connected by a one-storey walkway and serve as guest accommodation places. The technical inventory plan of 1992 shows that the design has changed over times, the building has three entrances, it is believed-communal flats [12]. Both servants' houses can be seen in the above mentioned land plan of 1873-1874.

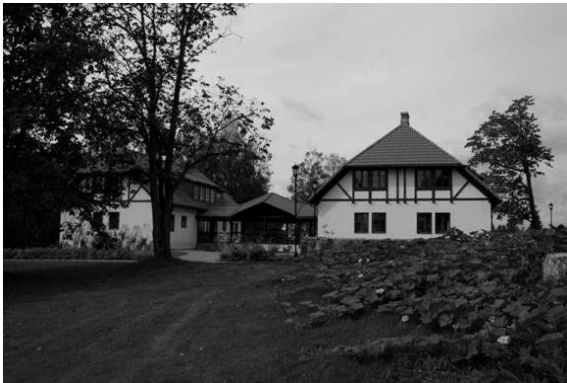
Fig. 7. The servants' houses  
[Source: photo by the author, 2009]

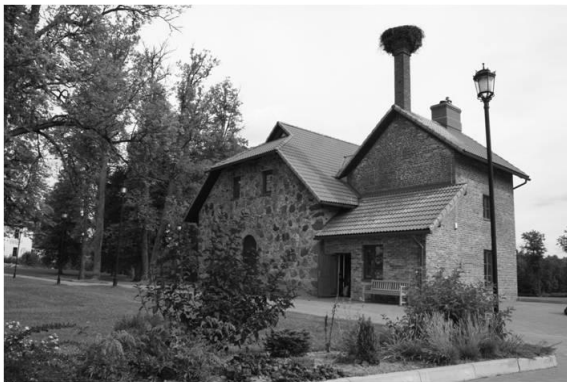
Fig. 8. The threshing barn with the drying-kiln  
[Source: photo by the author, 2009]

Quite an interesting building is the threshing barn with the drying-kiln which consists of two parts– the part built from the rubble, covered by a gabled ridged roof partly sloped at both ends of the ridge forming a small triangular window and later a red brick extension with an imposing chimney was added. This building has largely retained its authenticity. As shown in the photos of 1994, the building was covered with a temporary bituminous cover and waited for its further fate [12]. It turned out to be favorable and today the building pleases with its tidiness and renewal of the original appearance. The entire volume of the building is rather strange—a combination of the oldest and newest parts. It resembles the manor house's volume where to the rectangular building, covered with the gabled ridged roof, there was illogically additionally built a two-storey volume with a complex roof connection. The threshing barn with the drying-kiln is the same kind of building– the traditional, supposedly, the mid-19<sup>th</sup> century volume is adjacent to the 19<sup>th</sup> century final part in the place where it fits the least, forming a complex roof connection where, according to our climate, there will always be problems. Anyway, this unusual building is an important part of the Manor building and is a testimony of a peculiar reconstruction technique of the 19<sup>th</sup> century.

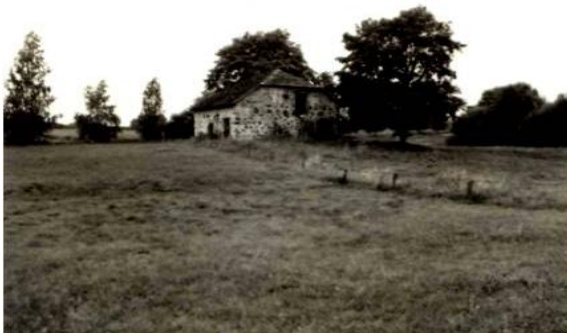
Fig. 9. The household building (forge) (photo 1975)  
[Source: State Inspection for Heritage Protection.  
Monument Documentation Center]

The household building (forge) is located further away from other buildings of the Manor, nearer to the lake. It was a rubble stone masonry building with small granite chip dents in mortar, covered by a steep gabled ridged roof with partially sloped ends. In 1994, the building was still in a satisfactory technical condition. The building, built in the mid-19<sup>th</sup> century, was not spared by time and in 2006, only the rubble stone masonry walls were left. These unstable structures were dismantled and from the remaining building materials, the building was reconstructed in 2007-2008, forming a different volume which generally fits into the historic building of the Manor.

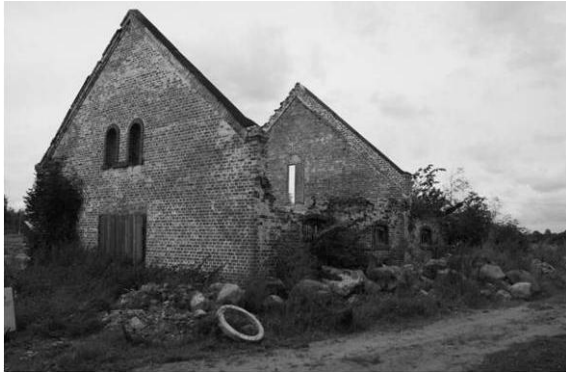
Fig. 10. The cattle-shed (photo 2009)  
[Source: State Inspection for Heritage Protection.  
Monument Documentation Center]

Until our days, in the form of ruins there has remained the cattle-shed which, supposedly, is one part of the feedlot seen in the plan of 1873-1874. The building consists of two parts—the cattle-shed and the threshing barn. In 1994, as shown in photo fixation [12], a part of the threshing barn was still under the roof but from the rest parts was left only rubble stone masonry walls and the chimney. Today, the walls of the cattle-shed part have still fragmentary remained but both ends of the threshing barn with the pediments built from red bricks still exist, though the middle part is almost collapsed. There have also remained windows of the threshing barn part— typical for a cattle-shed—small, with a segment-type lintel. The same ones were also in the

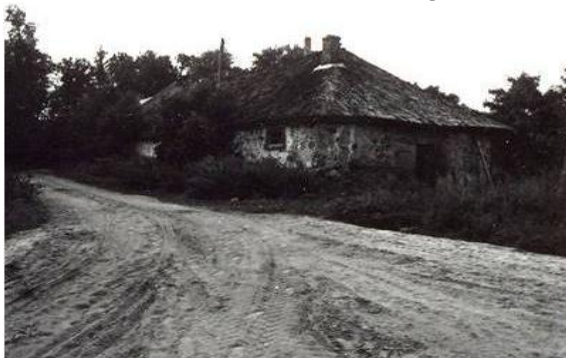
Fig. 11. The distillery (photo 1975)  
[Source: State Inspection for Heritage Protection.  
Monument Documentation Center]

It is likely that the building, which could have been a distillery, is seen in the photos of 1975 -it is long, with a steep gabled ridged roof cover [12]. For the walls, as for the nearby servants' house, there are used rubble stones and squeezed in mortar granite chips. cattle-shed part. During this time the building had, to a large extent, still retained its authenticity which is now entirely lost.

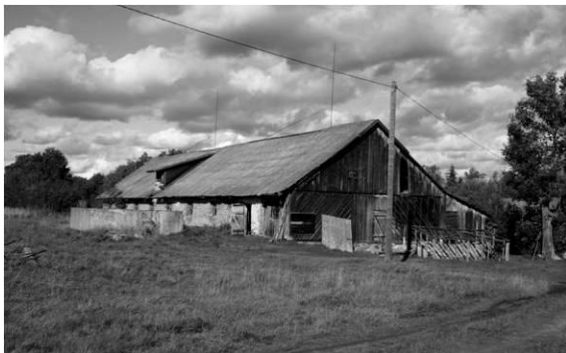
Fig. 12. The cattle-shed near the servants' house  
[Source: photo by the author, 2009]

Near the servants' house there is located the cattle-shed, built of red bricks and covered by a steep gabled ridged roof (the end of the 19<sup>th</sup> century). The building next to the servants' house creates a kind of a household ensemble which also includes the already mentioned cattle-shed, the possible feedlot part. Over time, the initial amount was supplemented by extensions-on both longitudinal facades which don't decorate the original appearance of the building at all.
