The revival of the Liepupe Manor - synthesis of the values of the architectural and cultural - historical environment over time

Jānis Zilgalvis, *a full member of the Latvian Academy of Sciences*

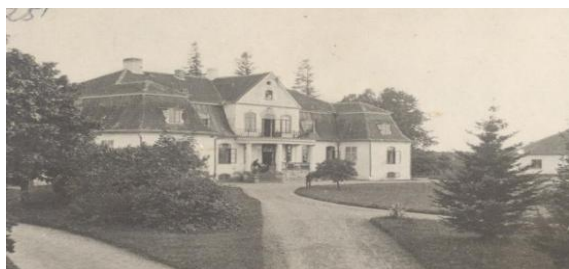
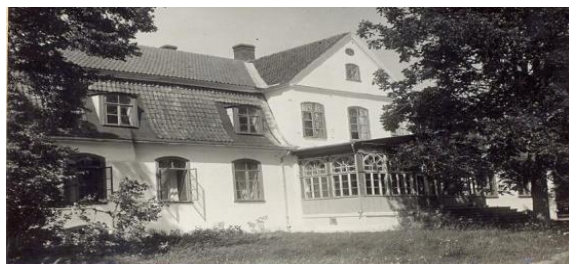
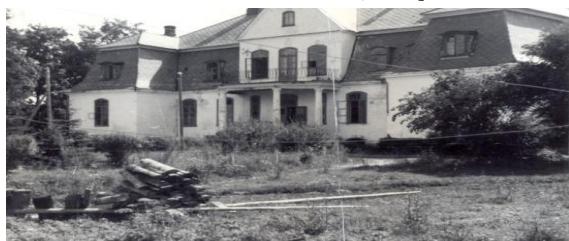
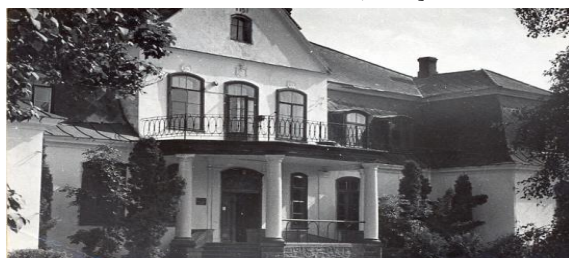
Fig. 1. Liepupe Manor House [Source: State Inspection for Heritage Protection of Republic of Latvia, Monument Documentation Center, 1929]

The Manor House is a one-story building, with the base floor and the attic floor, its main facade is emphasized by strongly raised risalites, with the roof ridge being lower than the basic ridge. In the center of this facade, a three-aisle axis mezzanine with a triangular gable is placed. In front of the main entrance, bilateral curved stairs are made, above which the columns support a terrace located at the second-floor level. The rooms on the attic floor are illuminated by the Baroque-type roof windows, the roof cornices are richly profiled. All the window apertures have semi-circular lintels, which gives evidence of the Baroque traditions in the architectural solution of the facades. The rusts of the volume corners are restored, which in the photos from the 1920s are not visible [5], but discovered in the research of the facade polychromy. No less impressive is the park's facade, which, although fails to have risalites, but the central part of which, just as at the front yard, is freshened by a mezzanine with a triangular gable. The eastern end facade has preserved the Baroque-type window angles and hinges. In the center of the first floor, there was a veranda, which supposedly was built later than the building itself – in the second half of the 19th century. The windows of the veranda were with a semicircular lintel and sumptuous arches were formed for them. Over time, the veranda has been lost and in its place a terrace is located today. A question arises – whether to restore the lost veranda from old photos and drawings? It seems that better – not, although – the vestige of another time, it was not really appropriate for the Baroque spirit in the building.

Viewing the Manor House today, the visual material should be looked at from the older to the more recent times. Separate latest photos of the Manor House date back to 1929 [6]. They display the main facade and the park's facade of the house. The Manor House was surveyed in 1949 (Architect M. Ozoliņš), which is also a material worth of research [7]. Here, though the author has made a mistake, as in the representations of the long facades – the roofs of both risalites with the basic

The author of this article has visited the Liepupe Manor several times. For the first time in 1977, when the Manor House was still relatively in a good technical condition. In 2004, it was hardly possible to take a picture of the deadly gone-down building from the front yard as it was hidden by pyramidal thujas and different shrubs. The park's facade did not look better – the plantations completely hid the first-floor facade. One part of the roof was covered with corrugated sheets of slate, the other one – with tin. Nothing better could also be viewed in 2008 – crumbling facades, desolation and hopelessness. Only the thujas had disappeared.

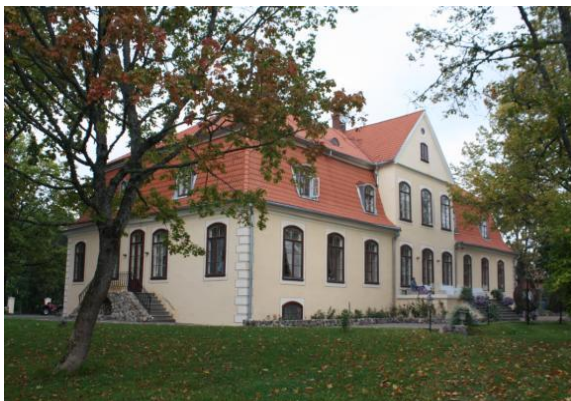
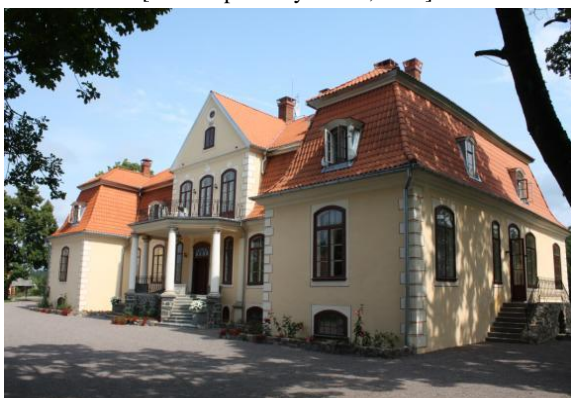
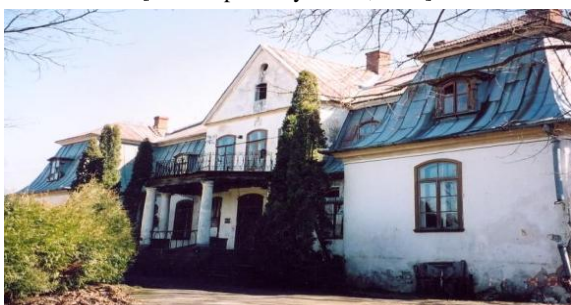
Fig. 5. Liepupe Manor House
[Source: photo by author, 2014]

volume are connected quite differently. In the photos of M. Ozoliņš of the same year, in front of the Manor House there can be viewed a muddy, rutted rural road with building materials scattered around, but all of the building's roof is covered with smooth square slate plates.

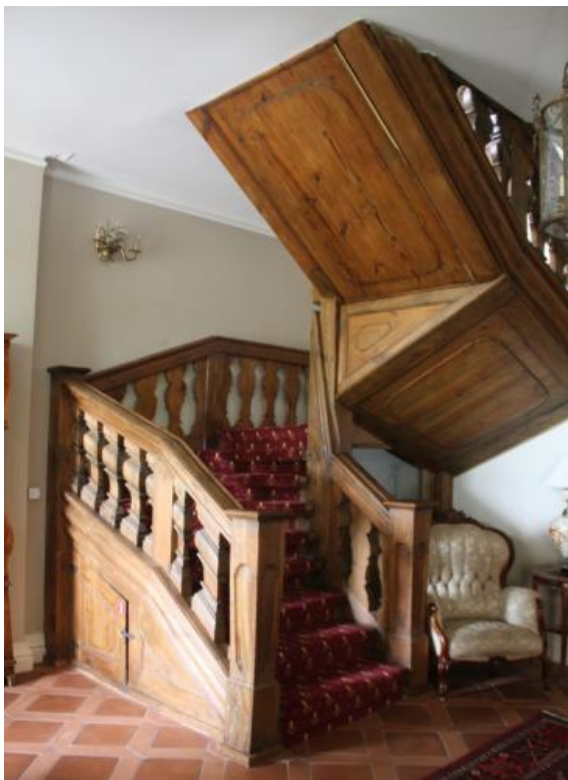
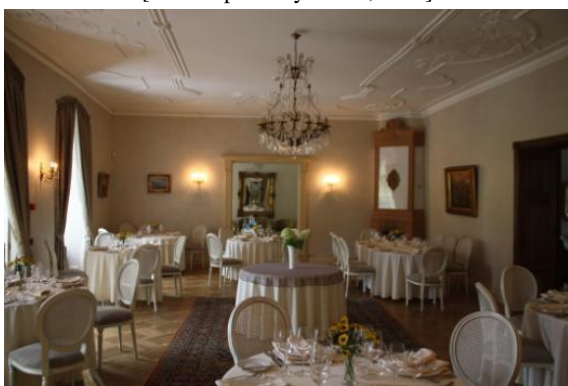
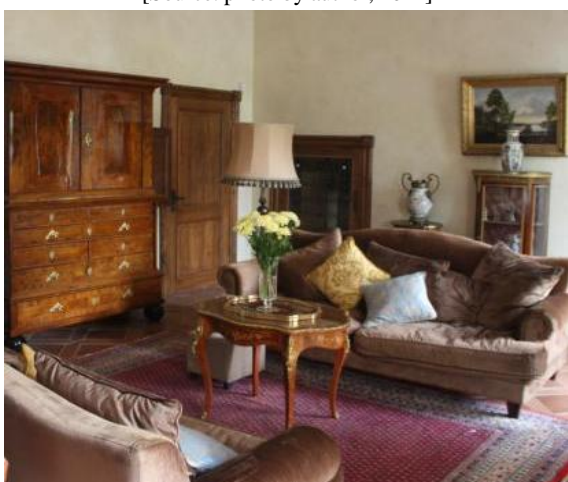
Fig. 8. Liepupe Manor House. Staircase
[Source: photo by author, 2014]

From the hall, before the historic wooden stairs, we reach a room illuminated by two windows. In the corner of the room, a fireplace of the second half of the 19th century is located, which is original and brought from some other place. Its tiles are embossed and polychrome. Especially luxurious is the cornice and the Baroque-style crowning. The ceiling formations of this room are very interesting and preserved from the 18th century, of course, restoring them and complementing the lost spaces. The waving and folding cornices, mutually alternating around the perimeter, frame the ceiling of the room. In some places between them, reproductions of the tiny petals are rhythmically arranged. In the middle of the ceiling, a square rosette is located and its surface is also topped with these petals. From this room, the stairs, called the wine stairs are leading to the cellar.

In the rooms on the second floor, historic roof structures are exposed, which give the rooms a special mood. The stairway has preserved the historical floor boards with an impressive widths, but in the central room the floor boards are arranged in a specific pattern, which is based on a cross, the four parts of which are filled with boards placed in the same direction. Such floor boards pattern is rare and only the Manor House at the Ķirbirži Manor and the Mentzendorff's House in Riga can boast of such one. On the third floor – in the attic an exposition is located about the history of the estate and two servants' rooms are also restored here, the upper

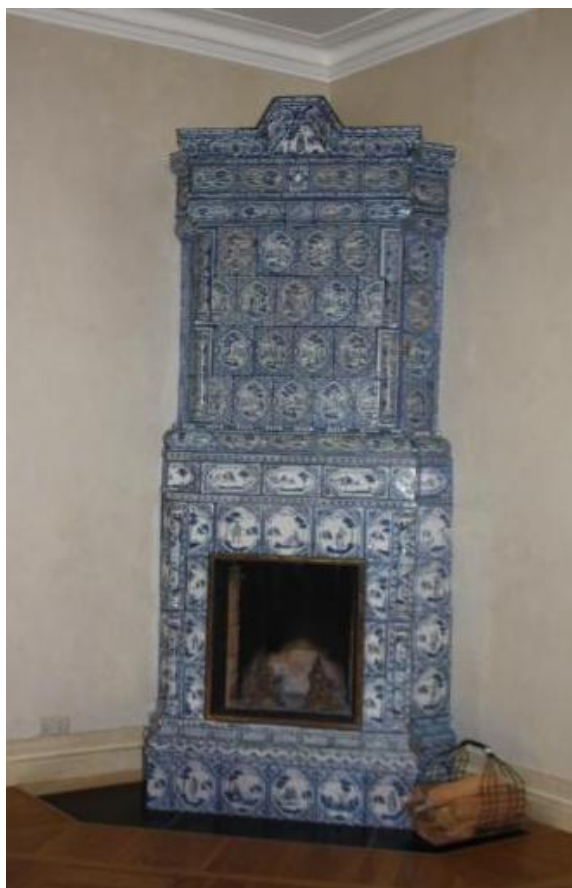
Fig. 12. Stove

Some tiles were missing, so the stove turned into the fireplace. And what do we see in the plot scenes of the white background-bluish tone paintings? They are southern landscapes with castles painted in the framework of Baroque-style convolutions, elsewhere with a musician in the foreground or a similar type with similar scenery in the background. The ceiling formations of this room are preserved from the 18th century, they are restored and the lost places are renewed.

The interior of the Manor House is photographed in 1929 and one of the photos shows the Baroque time stove, tiles of which are decorated with plot scenes [8]. After 1949, this stove was simply demolished and thrown away. In 2008, during the restoration work, one tile from this stove was found. This stove was located next to the Grand Hall, the current *Music Room*. And it was a great success, when the today's owners of the estate got a chance to buy the same stove, which was torn down in one place and many decades's was abandoned. As it turned out in the survey, the tile maker had been one and the same person.

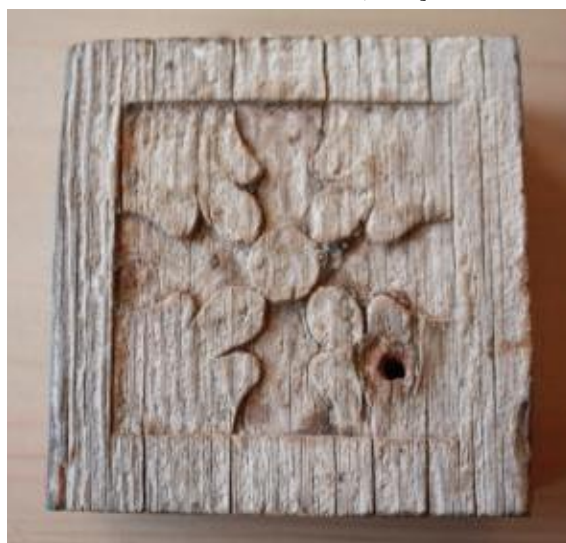
Fig. 15. Watermill indoor fragment
[Source: photo by author, 1977]

where in the building it was located. It is a square block of wood, on the surface of which, in the center of a perimeter frame, there was a circle with adhering stylized angels from four sides. Today, only the remains of the foundation and some remains of the rubble walls are left from the watermill.

One of the components of the estate building was the watermill. The large enough building was covered with a mighty steep gabled roof with partially tapered ends. The pediment of the building was constructed by trussed construction and in the center of the construction there was a door sash. In 1977, the building was still preserved, though its interior and equipment were vandalized and the neighborhood was in the trash. This is shown by the today’s photographic recording materials and survey materials, including drawings [13]. During that year, we managed to find an interesting detail in the abandoned building. Unfortunately, it is not known

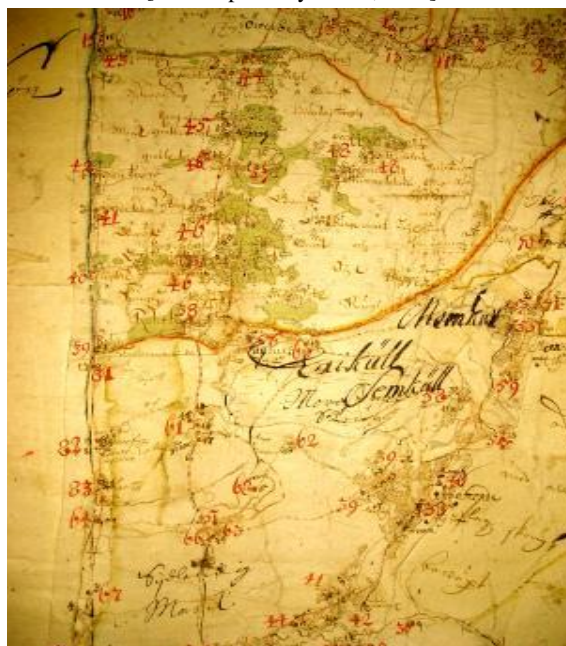
Fig. 16. Land Plan of Lāde, Liepupe, Dunte Manor.
Prepared by J. Becker. 1689 [Source: Latvian State Historical Archives, file 7404. 2nd description, 31.1]

Information about the location, situation and development of the estate is provided by the contemporary cartographic materials. The oldest of them is the land plan of the Lāde, Liepupe, Dunte manors drawn up by J. Becker in 1686 [9]. It contains only indication of the location of the estate, and yet it provides information that during this period an estate has already been located there.

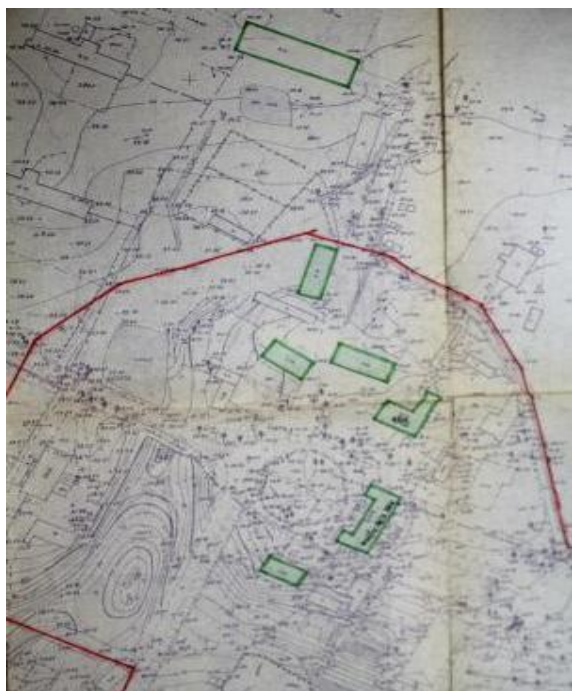
Fig. 17. Topographic plan with indications of monuments of architecture

The place of the estate is also visible on the Highway and Road Department map issued in 1979 [10]. The situation plan of the estate building is recorded in 1979 as well [11]. Later, the employees of the monumental defensive institutions created the building situation plan with the explanations about the purpose of each building [12]. Unfortunately, the functional role of the buildings is different in various materials.

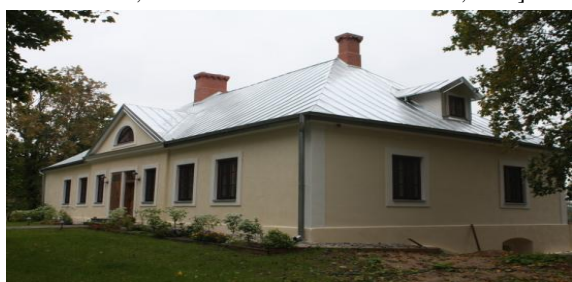
Fig. 18. Manager's House [Source: photo by author, 2014]

The Manager's House is the closest to the Manor House. The Manager's House was built in the Classicist-style traditions. The one-story building is covered with a steep gabled roof, the ends of which are tapered. The center of the main facade of the building is highlighted by a just slightly raised risalite with a triangular gable, in the heart of which there is a semi-circular window. This building, when viewing its stylistics, was rebuilt after the emergence of the Manor House. The skylights in the end facades are of a later formation, but specifically do not interfere with the general mood of the architectural image of the building. In 2014, a construction design is developed to house a democratic hotel and at the end of the same year the works were already drawing to a close. From the newly created terrace, located on the rear of the building (on the opposite side of the front yard), there will open a fantastically nice view of the pond of the estate, which is dammed there from the Liepupe River. The pond facilities for swimming are available here and from the platform it is possible to enjoy an extensive landscape with a bridge over the Lielupe River and the distant fields and forests.

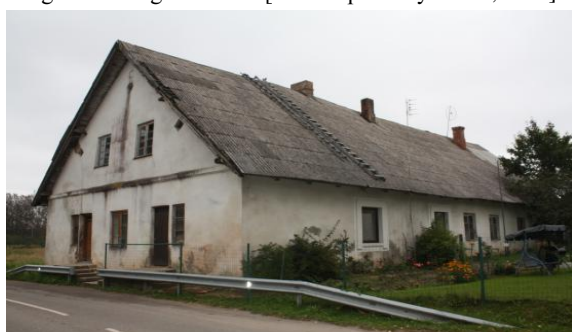
Fig. 19. Large Servants' House
[Source: photo by author, 2014]

The Large Servants' House (mid 19th century) is covered with a steep gabled roof, the stucco covered walls are tinted white, in some places the historic six-pane windows have remained, but in the main facade two windows without the division are built, which do not correspond to the architectural solution of the building. The building is partly inhabited.

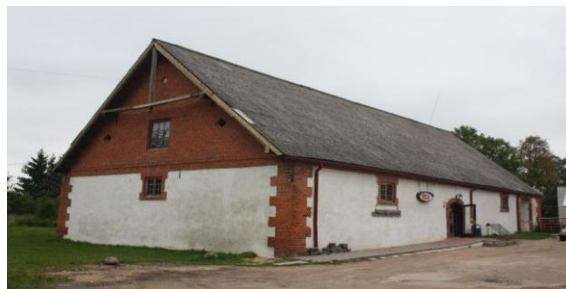
Fig.21. Barn [Source: photo by author, 2014]

The barn is one of the most architecturally interesting farm buildings of the estate (the second half of the 19th century). Its walls are colored white, but the pediments, corners rusts and edging of the apertures are made in the red brick, which tonally successfully contrasts with the wall coloring. The decorative solution of the corner rusts is an attempt to visually approximate this building to the appearance of the Manor House. The constructions visible in the pediments – the ends of the purlins and bundles, also add some attractiveness. The photographic recordings from 1994 show that the windows of the pediment of the building has had another, much more subtle panes [14], which are now simplified. On the rear of the building, an asymmetrical wing is located, which, judging by the architectural composition was built simultaneously with the main volume. If it is a one-story building, then the wing has two floors, with the first one constructed of broken boulders, but the second one – of the red brick. Today the barn houses a shop and utility rooms.

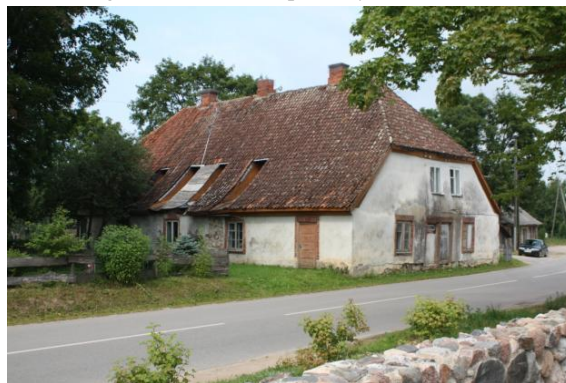
Fig. 22. Servants' House [Source: photo by author, 2013]

The center building of the estate also consisted of houses for the servants. One of them was called the Small Servants' House. It is an unwieldy, as embedded in the ground, covered with a steep, massive roof hat. This mighty roof, the ends of which are partially tapered dominates in the building's architecture. The building's form is pristine and it is associated with the formation of the estate building at the end of the 18th century – the first half of the 19th century. In the course of time, the external image of the Servants' House has not dramatically changed. In 2014, when the estate building was inspected, this building was not used, but it is a tempting proposition for whoever is here and desires to operate *in the taste of the estate*. In the course of time, the window apertures have

changed – instead of one window, there is a doorway, in some places the historic six-pane division is lost, replacing it with a simpler solution. But the finishing solution of the apertures is preserved in the facades – the red brick edging, which contrasts with the white tinted plaster of the facades.

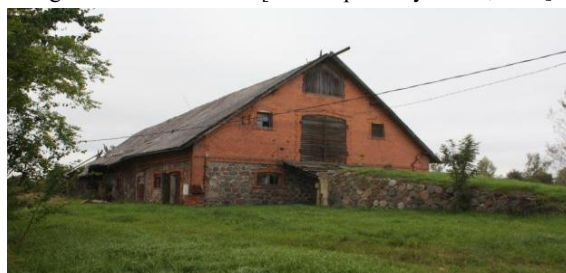
Fig. 23. Cattle-shed [Source: photo by author, 2014]

The cattle-shed with the end ramp is located away from the center of the estate building and reachable by walking past the Coach House. It is a building of the second half of the 19th century, which impresses with its scale and the mighty shape. The stone building is covered with a steep gabled

roof. At the end facade, a ramp to the second floor is constructed, it is also thought of the architectural ensemble of the pediment, as far as possible its apertures are decorated. Today, the existence of this large and architecturally interesting building is endangered as its roof is partially collapsed, the walls toppled and the indoor space is dangerous for visitors. The building's first floor is constructed of broken boulders, the pediments – from the red brick – the edging of the apertures is made of the red brick in the form of rusts, the same kind of the material is also visible in the roof cornice and the corners of the building.

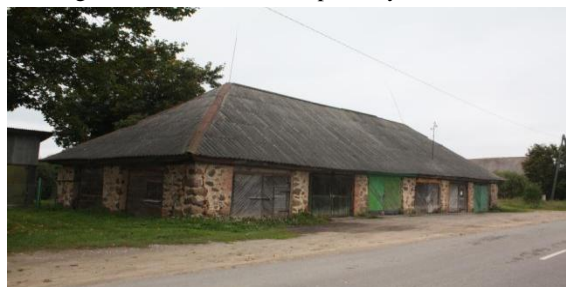
Fig. 24. Coach House [Source: photo by author, 2014]

The Coach House (the 19th century), often also called *vāgūzis* is covered with a mighty steep gabled roof, the ends of which are tapered. The walls of the building are constructed of broken boulders in mortar squeezing in small granite chips – a classic facade finishing solution for the estate and often sacred architecture.

The edging of the apertures was probably built from the red brick. In the Soviet time, the building housed garages, as shown by the uglified main facade – side by side placed gates – of different sizes, finishes and shading. It seems that one of the end walls is authentic, where between the parts of the brick walls there are two symmetrical parts of horizontal beams and a two-piece six-pane window is built into each of them.
