# Smiltene Rectory: authenticity and the issues of its preservation

Jānis Zilgalvis, *a full member of the Latvian Academy of Sciences*

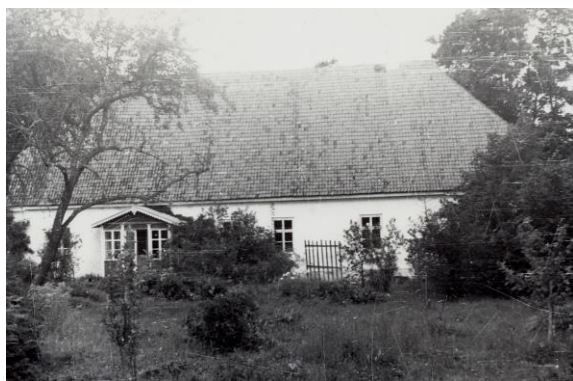
Fig. 1. The Smiltene rectory, 1949  
[Source: State Inspection  
for Heritage Protection of Latvia]

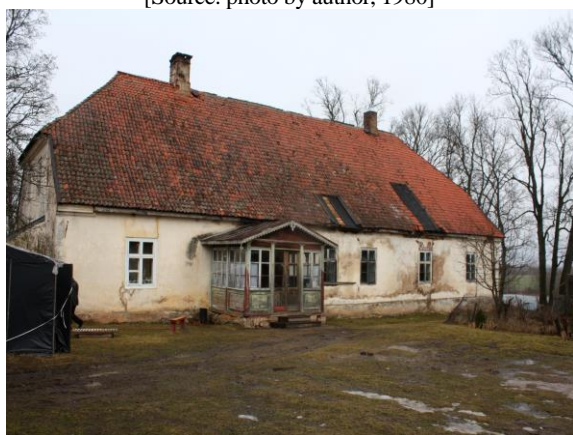
Fig. 3. The rectory from the garden side  
[Source: photo by author, 2015]

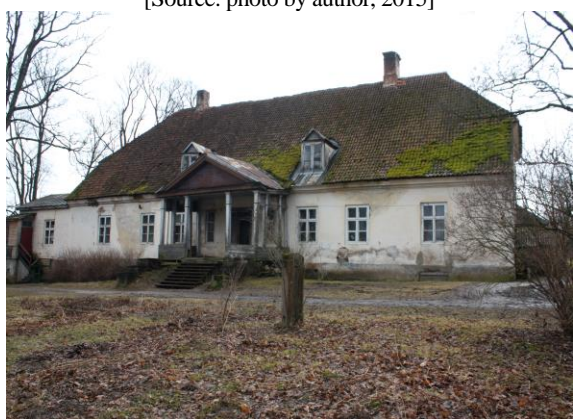
Fig. 4. The rectory from the backyard side  
[Source: photo by author, 2015]

A continued existence of the building is a current issue, as one end of the ceiling has collapsed, the roof is leaking, the stairs of the porch are half-dilapidated. In order to carry out the restoration work, an advice of a knowledgeable specialist is required. It is to be hoped that the inhabitants of Smiltene and the entire Latvian society will not be indifferent to this building and it itself will tell the next generations about the times gone by, not making study descriptions and photographs. Reinis Kulbergs and the parishioners are more interested in grabbing the chance of saving the ancient building, as it is not only a worthy architectural site – it also contains significant pages of our nation's history of culture.

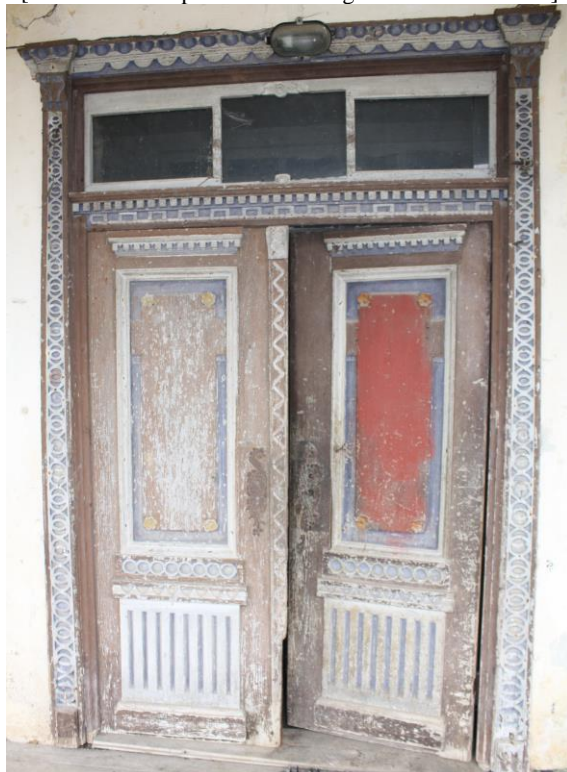
Fig. 6. The main entrance door wings of the rectory  
[Source: photo by author, 2015]

The upper paneling is surrounded by a profiled strip. Its central part is highlighted by a cross-type form, the corners of which are adorned with rosettes, but the side protrusions in the bottom part with pairs of elements of the Doric order. The door latch is decorated with a zigzag motif, in its capital there is a palmette. Above the upper paneling, a profiled band with a décor band is visible. The bottom door paneling is grooved and protruded. It is separated from the upper one by bands of rhythmically sorted circular elements. Under the upper door, the casements are decorated with a meander motif ornament and a décor band. The importance of the portal in relation to the artistic composition of the door wings is negligible. It is just framing the aperture, and its decorative solution is quite mixed. In the middle part of the window of the upper space of the door, there is an oval crown-like garland and from its center a festoon-type decor reaches both side windows. Unfortunately, none of it has survived [4].

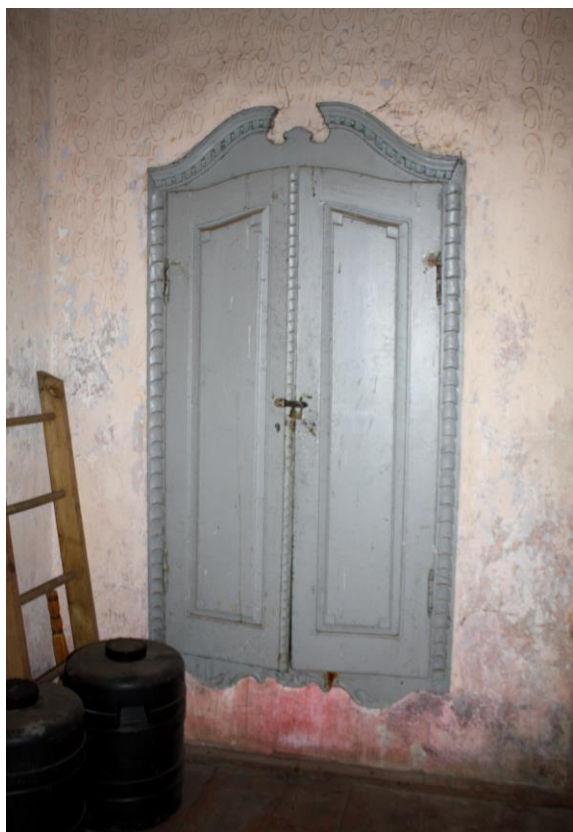
Fig. 8. The wall cabinet  
[Source: photo by author, 2015]

A double way wall closet has also survived in the lobby of the rectory in Baroque forms with a relief Rococo decor at the bottom and a broken gable at the top. It has served for placing dishes. These wall closet wings in the Latvian architecture are a rarity, especially, from this period of time. But a freely standing wardrobe with this crowning is not uncommon, it may be met in both manor houses and in the building attributed to the popular construction. Paneling has a slightly concaved top, which supposedly follows the graceful concave of the gable. The paneled corners are accentuated by squares characteristic of the Classical time.

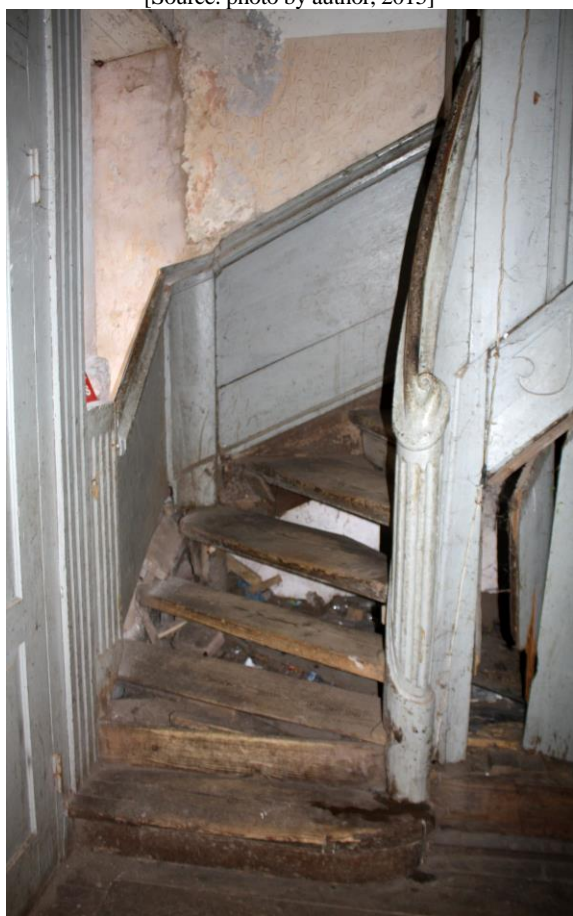
Fig. 9. Staircase of the Smiltene rectory  
[Source: photo by author, 2015]

There, stairs with a concave slope are visible – recently fixed, but the artistic stylistics and authenticity has largely been maintained, the sides of the slope are decorated with a wavy meander, but the railing – with an arcature motif. The wooden roof structures of the building, the wide plank flooring, the wear of which indicates a long life, the indoor wing paneled design and the mantel chimney are also noteworthy, which, unfortunately, has been lost due to the Soviet-era transformations, fragments of which are visible in the far end living rooms on the second floor. Almost in all rooms, the cornices of the ceiling wall folds are visible. They have survived differently, but their nature is still readable.

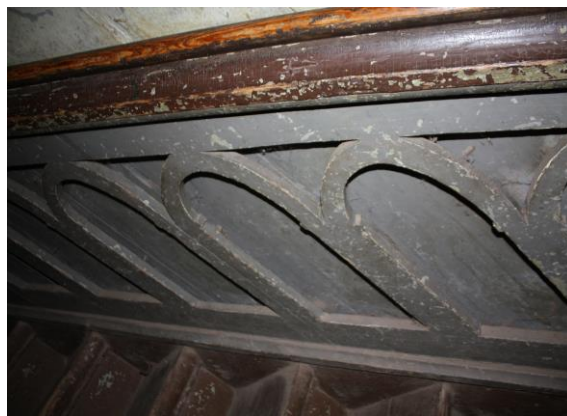
Fig. 10. Staircase [Source: photo by author, 2015]

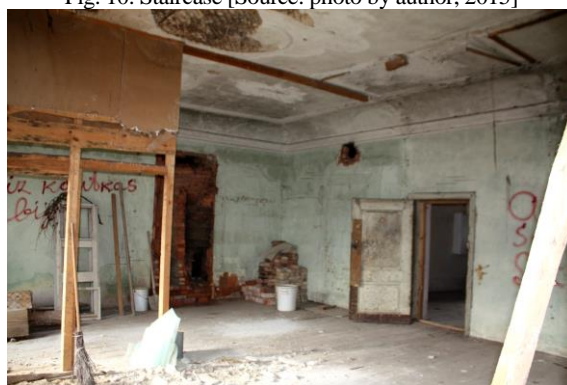
Fig. 11. The central room of the Smiltene rectory  
[Source: photo by author, 2015]

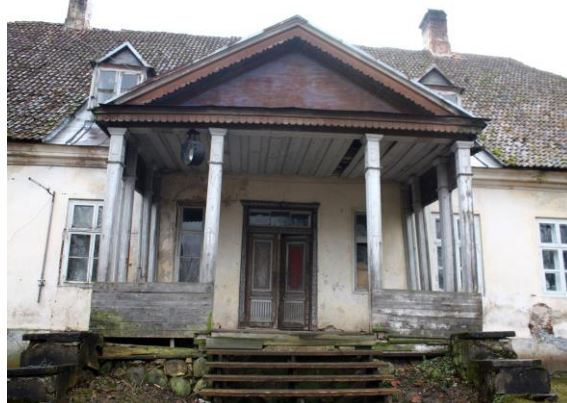
Fig. 12. The main entrance of the Smiltene rectory  
[Source: photo by author, 2015]

At the main entrance, there is a porch, which is made much later, after the construction of the building, supposedly, in the first quarter of the 20th century. It also has its construction history. The triangular gable, the cornice with a silhouette adornment is supported by three pillars on both sides [6]. The porch is in a rather sad condition in 1980s, but the pillars are still in their places. And then, in 2001, the pillars become on two ones less. As a whole, the porch has survived to the present day, its staircase has decreased in width. There is an idea to restore this nice porch. Also, in the second longitudinal facade of the building, there is a small veranda at the asymmetrically placed entrance. The stylistics is similar to the porch above. Even today the veranda is in a good condition.

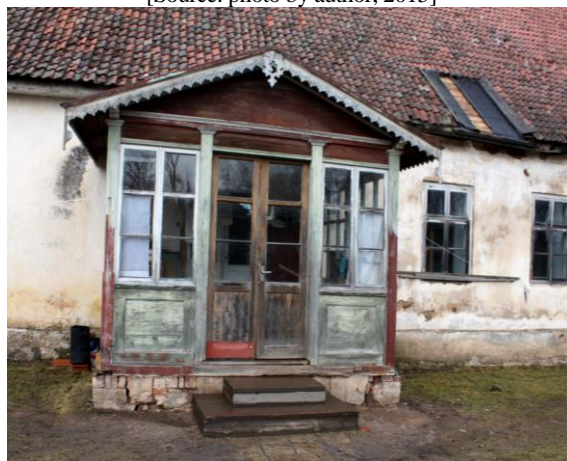
Fig. 13. The garden entrance of the Smiltene rectory  
[Source: photo by author, 2015]

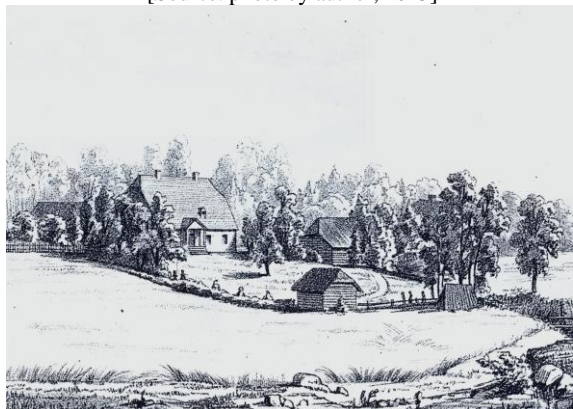
Fig. 16. The Smiltene rectory  
[Source: Sivers J. Smiltēn., Rīga: Kymmēl, 1872]

The Smiltene rectory is depicted in a drawing of the second half of the 19th century, which is published by Jegors Zīvers [11]. The rest of the building is also seen there – the two log houses, a cellar and a house in the garden, from which only the roof is visible. Only the rectory is in its place today as the building has changed over time. One of the log houses could be the old barn with a porch and haylofts in the photo published by K. Kundziņš [12]. Barns - log houses on high masonry foundations, built in 1794, are also seen there. These buildings are closer to the cowsheds, the so-called - stockyard as they are connected with a masonry fence and form the inner yard. The Smiltene rectory is also documented in the 1930s in the materials of the Monument Board. The building is photographed from both sides and provides rich information about the situation of those times [13].

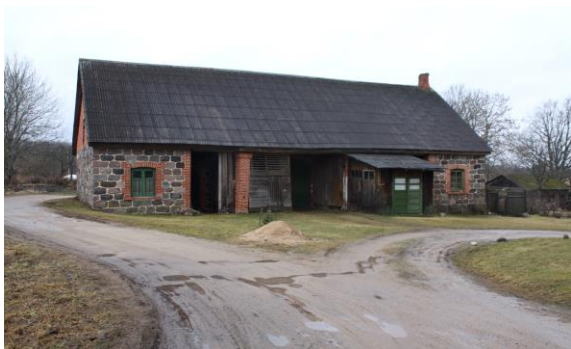
Fig. 17. Stables [Source: photo by author, 2015]

As a whole, the complex has not survived, but several other houses, though far newer - houses of the second half of the 19th century have not gone. It is a stable from nice masonry rubbles and red brick columns, forming up a porch, built in 1905, as it is evidenced by the year inscribed with stones, a school house - a rather large one-story building with a steep gabled roof and a mezzanine, which during the Soviet times is bricked with silicate bricks, a small masonry dwelling house with an entrance from the end (the second half of the 19th century). It is located close to the rectory, and, presumably, it is a washing house. Its one end is decorated with an aerated concrete block annexe building, and someone, also partly driving into the historic building, has turned it into a garage. In turn, on the edge of the lake, there is a small rubble masonry building with a steep gabled roof hat with the ends partly tapered (the middle of the 19th century). It is possible that this building has been a small cowshed, but it could just be a barn as well. At the beginning of the Soviet time, there is a shop, later a barn. From the side of the entrance, the roof overhang is interestingly shaped with carved rafter ends and beam supports. The fanatical researcher of the cultural history of Latvia Sigurds Rusmanis writes about the economic complex of the personage as follows, *“Instead of the horse stable and coach-house burnt down In the fire*

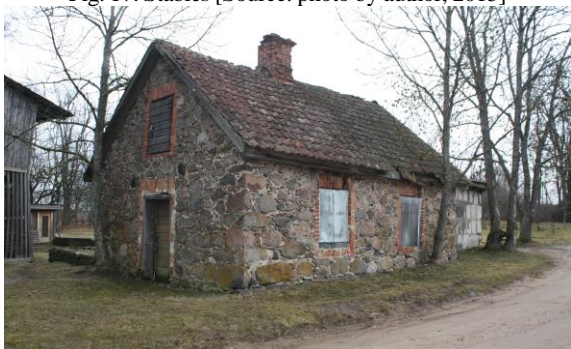
Fig. 18. The washing house  
[Source: photo by author, 2015]

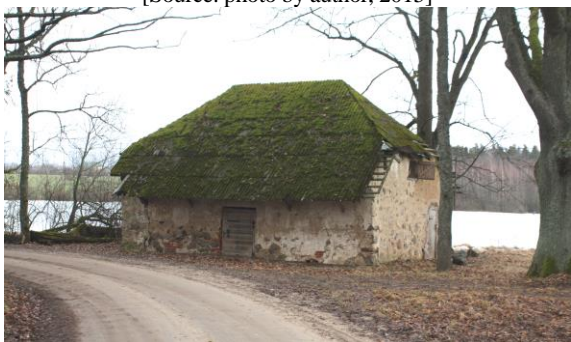
Fig. 19. Barn [Source: photo by author, 2015]
