Valle Rectory: the research of the cultural and historical environment and landscape

Jānis Zilgalvis, Dr. arch., *a full member of Latvian Academy of Sciences*
Mārcis Zilgalvis, *architect*

Abstract. It is essential to maintain the cultural and historical environment and landscape in places where it has not lost its quality and the original substance. This environment consists of buildings, the road network, water bodies, the terrain, plantations, etc.. In this respect, rectories are no exception and often determine the cultural and historical values of a more extensive landscape. The Valle parsonage is one of such exceptions.

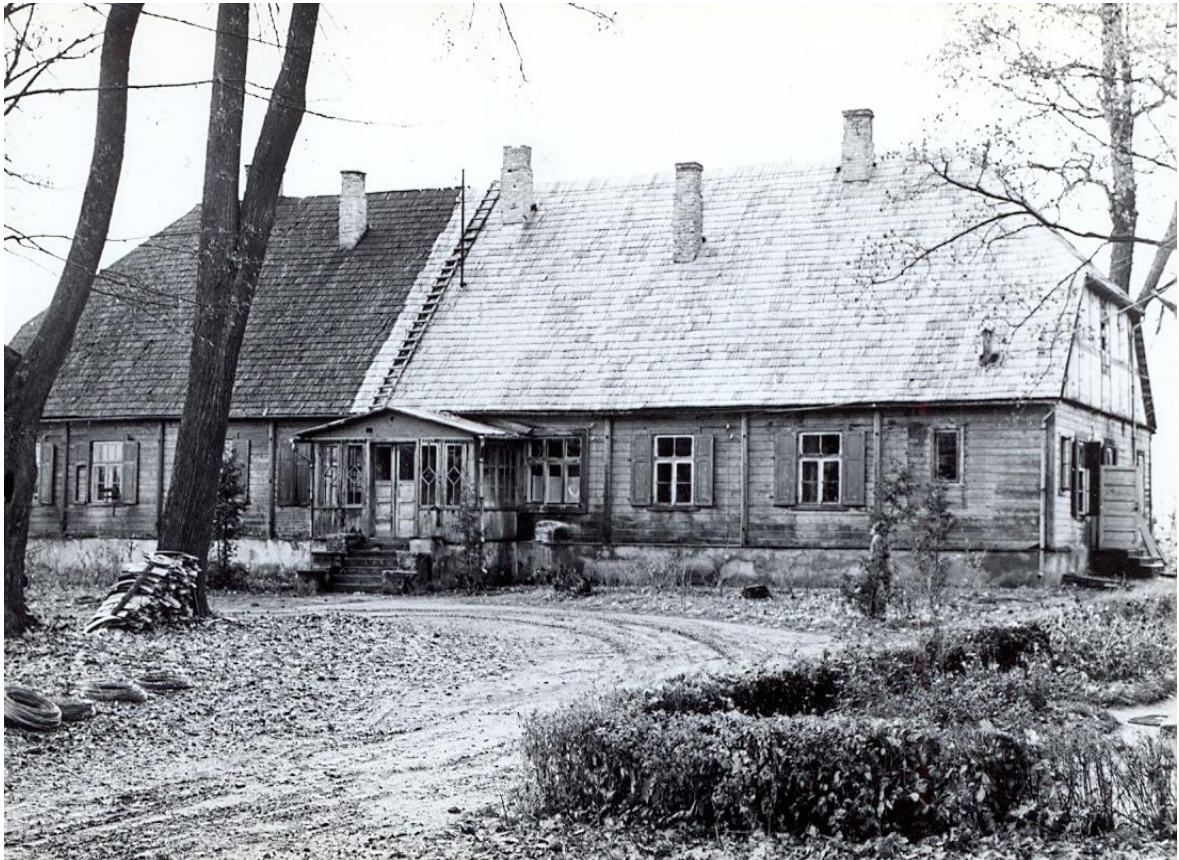
Fig. 2. The Valle pastor's house
[Source: State Inspection for Heritage Protection of the Republic of Latvia, Monument Documentation Center, the 1960s]

In 1964, Valle Lutheran Church was forcibly liquidated and a hospital, telephone exchange, and other institutions found their place in the pastor's house. The technical condition of the building at that time was in a satisfactory condition. This is evidenced by the photo fixation of the 1960s – the roof repaired, scuppers in place, the window glazing and shutters in their place [9]. Over time, the above authorities left the house and the next year it stood abandoned. At first, the rain and snow caused the northern end to rot as during the kolkhoz times the slate roof was put only in the southern end. In 1995, the roof structure and exterior walls were in their places, although from the attic the sky could be easily watched. In a couple of years, in 2000, the exterior wall of the northern wall came tumbling

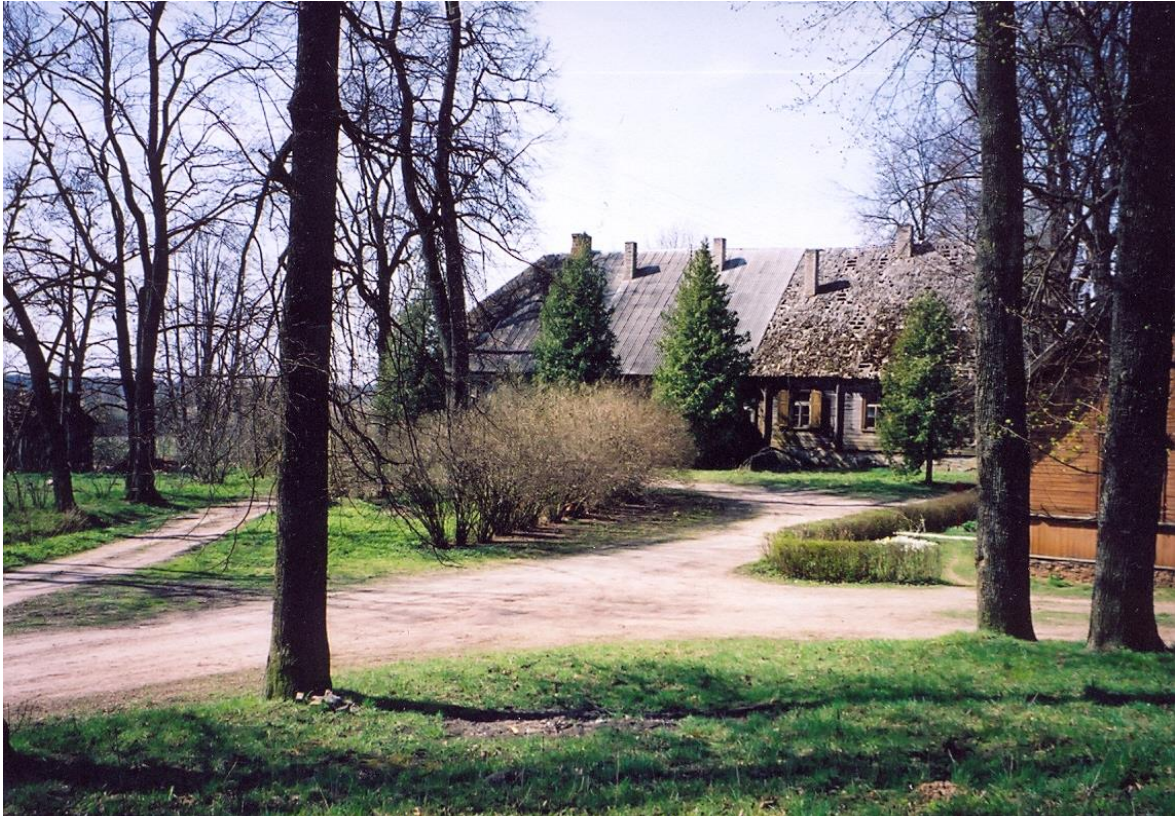
Fig. 3. The courtyard of the Valle pastor's house [Source: photo by author, 2001]

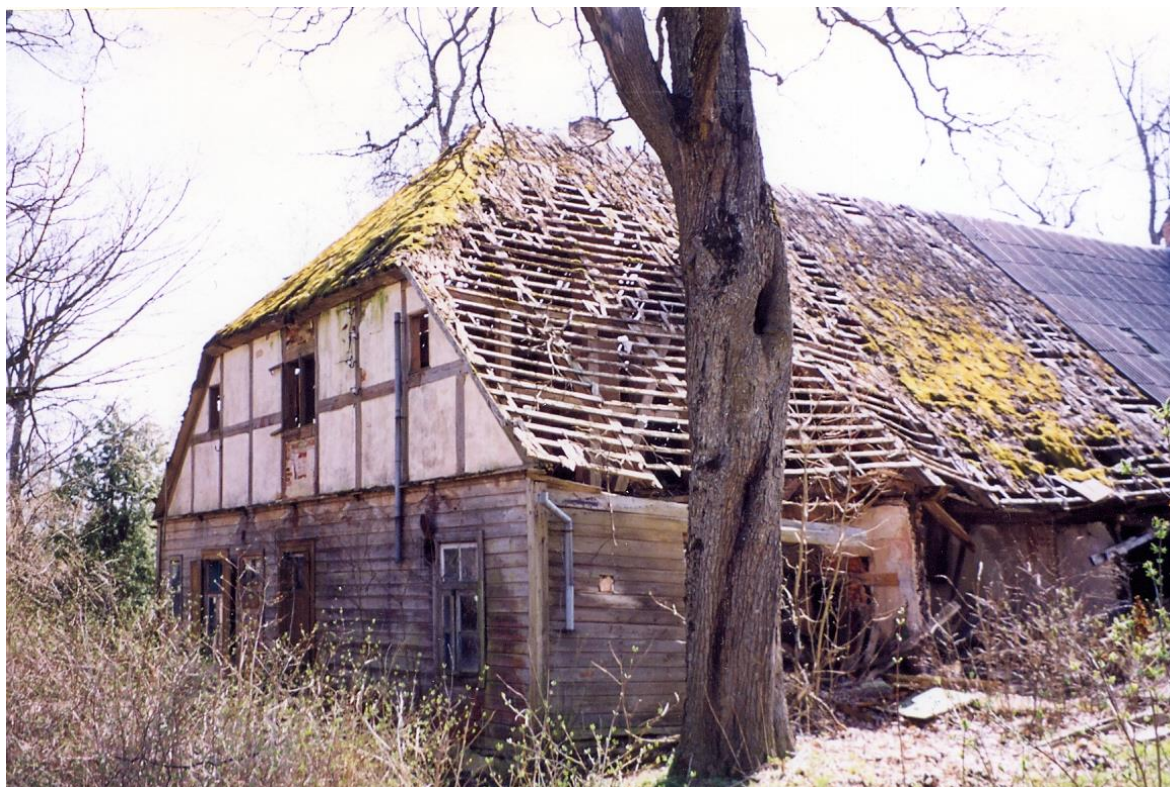
Fig. 6. The northern end of the Valle pastor's house
[Source: photo by authors, 2001]

down, but the rafters and roof trusses still stood - the artisans of the past centuries did their work with honor. But in the winter of 2002, at that side of the building the roof came tumbling down - it partially collapsed, also tumbling down several inner walls. The southern end of the building was in a relatively better condition, but the rooms were demolished as well – the stoves abandoned, broken windows in some places, the doors, shutters disappeared, the roof began to leak. As concerns the pastor's house, something was done at that time. Activities started in the late 1990s, by involving the local communities' attention to this site. In 2000, surveying and the architectural historical research of the pastor's house were carried out [10]. In a year, the reconstruction and the development of the development concept followed [11]. These materials indicate that the room group of the parish council is selected to be the main center and core of the functional solution of the building, where the second type of use would be organizing banquets, seminars, round-table discussions, etc.. The research stresses the open nature of the pastor's house and accessibility for all, whom the parsonage atmosphere is close to the hearts. In the group of the rooms for meetings, space was left for the so-called Mancel's room, intended as a sort of the parsonage museum, the exposition of which among other stories would tell about G. Mancel. It is indicated that the Mancel's room should not be a sterile museum hall but a practically usable room located near the meeting room. The southern end of the building would serve as the pastor's dwelling. It was proposed to place an archive, Sunday school, choir rehearsal room, etc., at the northern end. On the attic floor of the building, the guest rooms were intended. Unfortunately, due to the lack of resources, the practical action did not take place. What can we view today? One side of the ancient building has completely collapsed, the other - the southern side is still stubbornly holding out against its own fate, but how much longer? Renovation of the building is still possible thanks to the measurements and a detailed photo fixation.

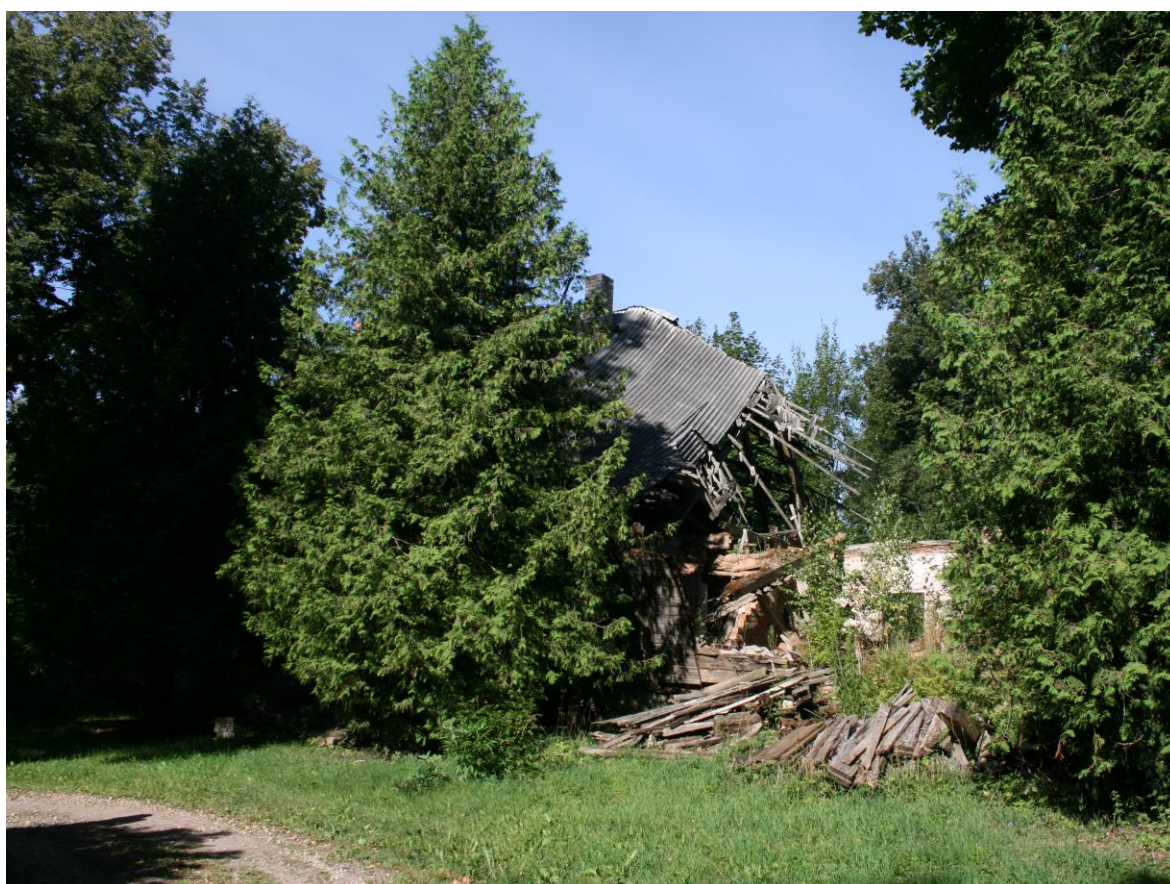
Fig. 7. The pastor's house from the side of the yard
[Source: photo by authors, 2008]

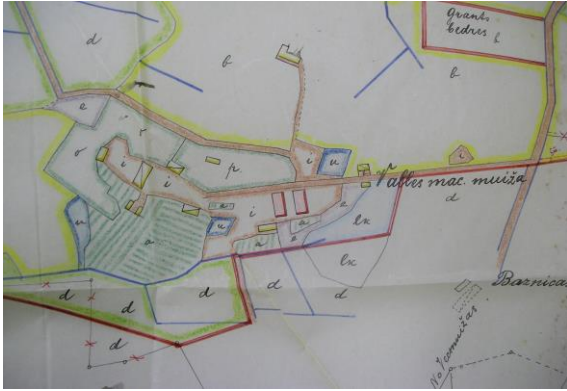
Fig. 8. The layout of the rectory land
[Source: Latvian State Historical Archive,
1679, f., 172. descr., p. 196.]

The pastor's house was the main building of the pastorage and around it other buildings – the dwelling and household buildings. We can judge the situation of the building in 1922 by the *description of the Valle pastor's house, sextonate and the former Valle church tavern buildings* [12]. The following buildings of the parsonage are mentioned here: 1 *dwelling house*, 2 *outhouse of the dwelling house*, 3. *granary*, 4. *granary*, 5 *dwelling house*, 6,7 *outhouses of the dwelling house*, 5., 8. *fire-wood shed*, 10. *dwelling house*, 1.1 *cellar to the dwelling house*, 10. 12. *pigsty*, 13 *cattle yard* 14, 15 *pigsty*,

16 smithy, 17 kiln-house, 18 barn, 19 threshing floor. The same situation can also be seen in the same year's plan of the division project of the Valle rectory, the sextonate and the land of the Valle state-owned church tavern [13]. Unfortunately, the plan does not indicate which each building is. However, by its nature and location, as well as by other information it can be judged that, in general, the center building of the manor accounted for nearly seven buildings: the rectory, servant (lessee's?) house, two stone outbuildings, of which the largest one could be a horse stable and instead of the foundation adjacent to it – a cattle-shed (these buildings could also be named as a cattle-yard). At the other side of the courtyard, a post office is located opposite the servants' house, finding its place there already in the start of the 20th century. In 2000, there was a bread oven in this building and its planning was not significantly altered. It is presumed that the post office was housed in some other building, belonging to the rectory. Behind it, the barn of the rectory is located but the small log bath-house is recently built from the timber of an older building. Behind the pastor's house, on a small hill, foundations of a building can be traced, above the ground of which only a few boulders are visible. Was it the oldest pastor's house associated with the name of G. Mancel? Interestingly, those big trees are planted exactly around this place. According to its dimensions, it has been much smaller than the existing pastor's house.

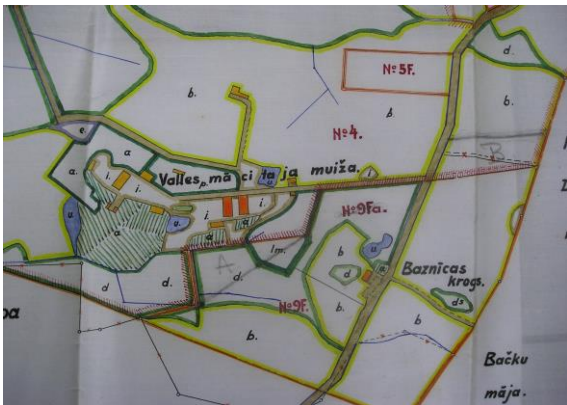
Fig. 9. The layout of the rectory land
[Source: Latvian State Historical Archive,
1679, f., 172. descr., 196.1.;]

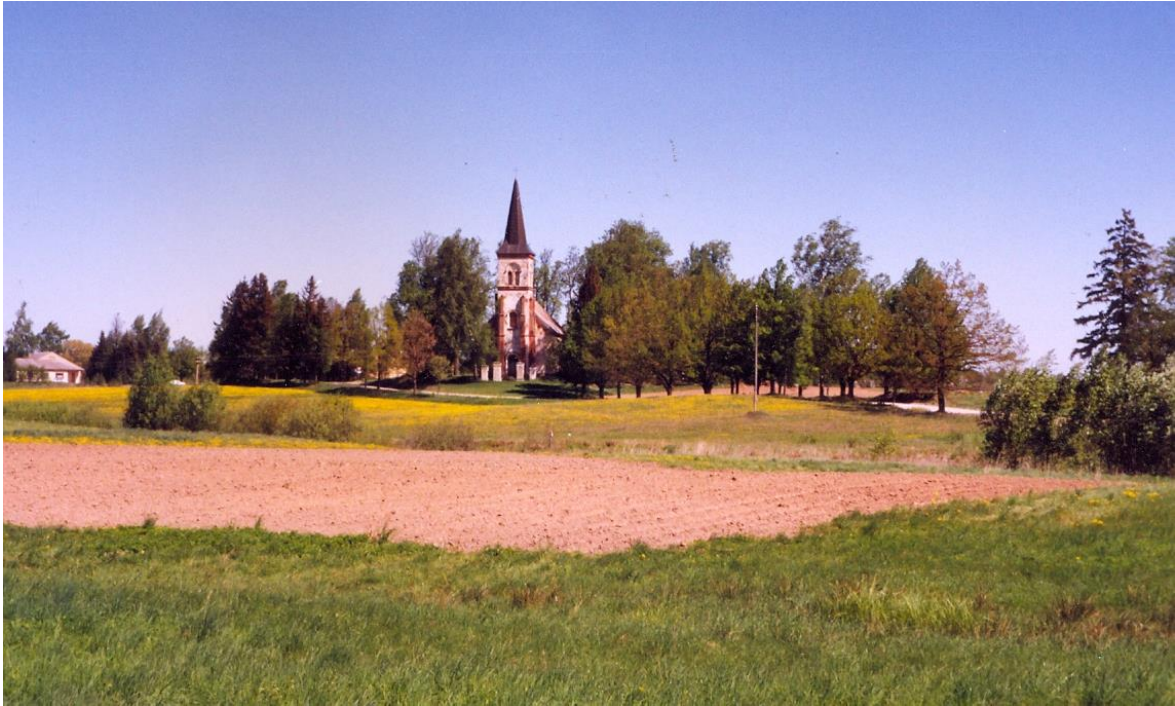
Fig. 11. Valle Lutheran Church in the landscape [Source: photo by author, 2000]

It is very important to maintain the cultural environment and the landscape around the center of the rectory. Close to it, there are still many buildings, their groups, and places *ideologically* related to the parsonage. The first of these is the church – a hall type one with a narrow polygonal altar part and its annexed sacristy. In the 160s, the church (1781–1785, 1874) was ruined – the equipment plundered and burnt, unattended surroundings, a dilapidated tower. The parish has

regained their church in the start of the awakening. Now the building has been restored, a new roof is built, the surroundings are attended, in 2001 the church equipment – the altar, pulpit, benches and the organ-loft made by Riga Craft School are consecrated. Nearby the rectory, *Zvanītāju Bukas* is located - a farmhouse, the hosts of which for several generations have served at the church as bell-ringers. The producer Alfrēds Amtmanis – Briedītis (1885–1966) and his brother – the actor, and

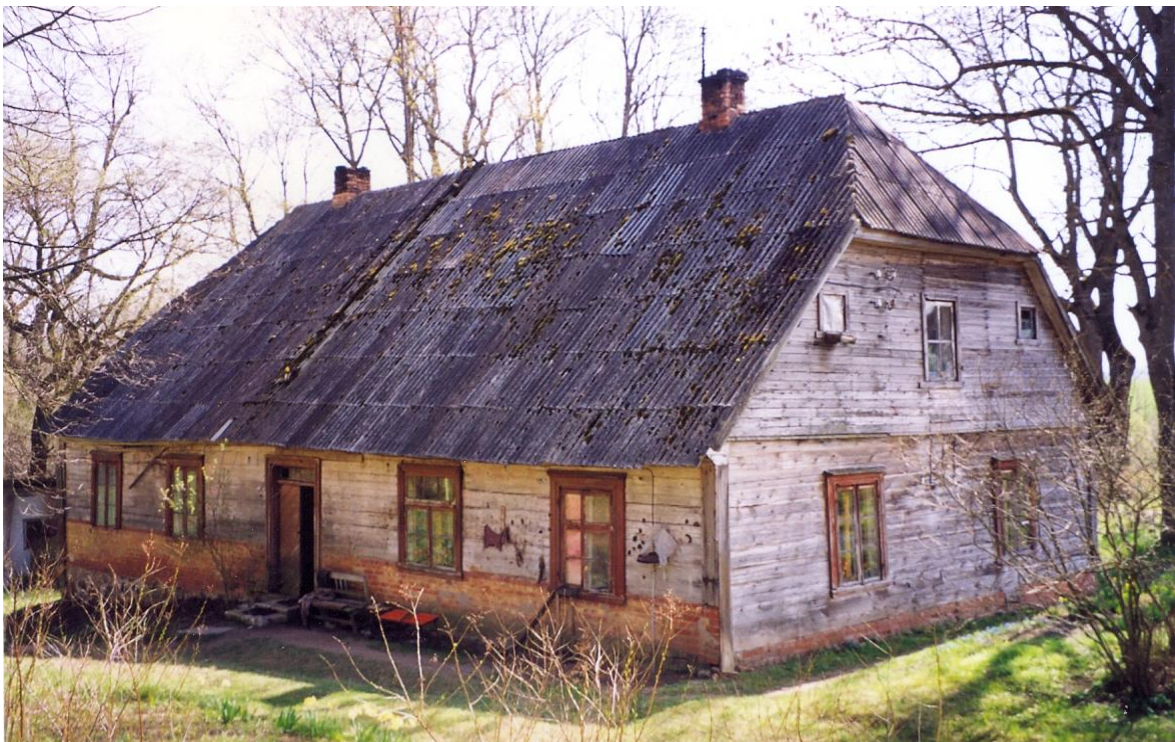
Fig. 12. The servants' (lessee's?) house [Source: photo by author, 2000]
