Krimulda Church and the cultural and historical environment around it

Jānis Zilgalvis, *Dr. arch., a full member of the Latvian Academy of Sciences*

Abstract. Krimulda Lutheran Church is located at Krimulda Parish of Riga Region. Together with the rectory building, the place of worship is included in the list of the State protected cultural monuments. Over time, the cultural and historical environment consisting of historical evidence archaeological sites, landscape elements, etc.. In the vicinity of the church has little changed, the spatial structure of planning is also retained. With regard to today's activities, it must be ensured that the environmental quality is not compromised. That's why its research remains topical and necessary in the broad neighborhood context.

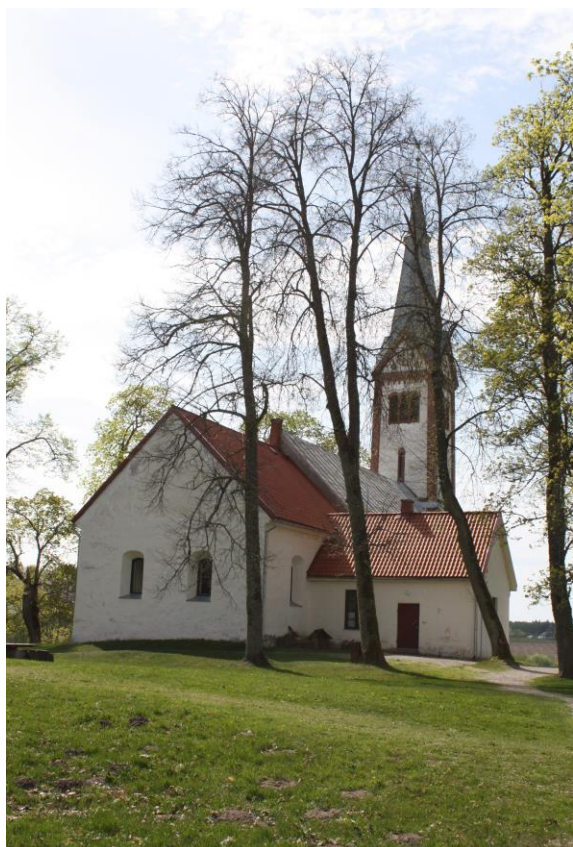
Fig. 3. Krimulda Lutheran Church
[Source: photo by author, 2016]

Krimulda (*Kremon*) Church is now the oldest, recognized as serving to its task church in Latvia. The building was built from 1205 until 1206 from boulders and dolomite, its oldest part, attributable to the 13th century, is the altar part. It is covered with a dome-shaped arching divided into eight sectors. Originally, the rib bricks were rough and contrasted with the white vaulted sails. Over time, the ribs and vaults were covered with lime mortar and during the repairs of 1902–1905 with a thick cement mortar that changed their subtlety. The sacristy adjoins the

In 1865, thorough repairs of the church were made – the pulpit was moved in another place (the current one), the triumphal arch was significantly widened, a new plaster ceiling was installed, benches and doors, new floors were partially installed, the walls were painted, etc.. There was a basement below the church which was completely walled up. In 1898, the dressing chamber was expanded by rebuilding the chamber into space for children to be baptized and newlyweds. The following year the repairs of the church were made – the altar room was painted, the old glass of the windows was replaced by new stained-glass windows made by Ernst Tode (*E. Tode*, 1858–1932) in his workshop in Riga. The works were financially supported by the owners of Biriņi (*Koltzen*) and Sējas (*Zögenhof*) Manors, as well as by the Latvian church members. Already in 1899, it was decided to build a new church tower. In 1902, the foundation was laid and it was finished in 1905. The construction works were led by the construction master from Sigulda – Jēkabs Ozols. The tower project was developed by the architect August Reinberg (*A. Reinberg*, 1860–1908). In architecture, the formal direction of the eclectic style dominated – the so-called brick style. On the background of the lightly tinted walls, elements formed in the brick-lay pattern were highlighted – eaves, arcades, window isle borders. The first floor of the tower with the prospective portal and the stairway extension on one side was built entirely of bricks. In order to architecturally link the new tower with the historical volume, small ornamental corner turrets and a rhomboidal belt below the sides of the pediment were created – the same as on the tower and the stairway extension facades.

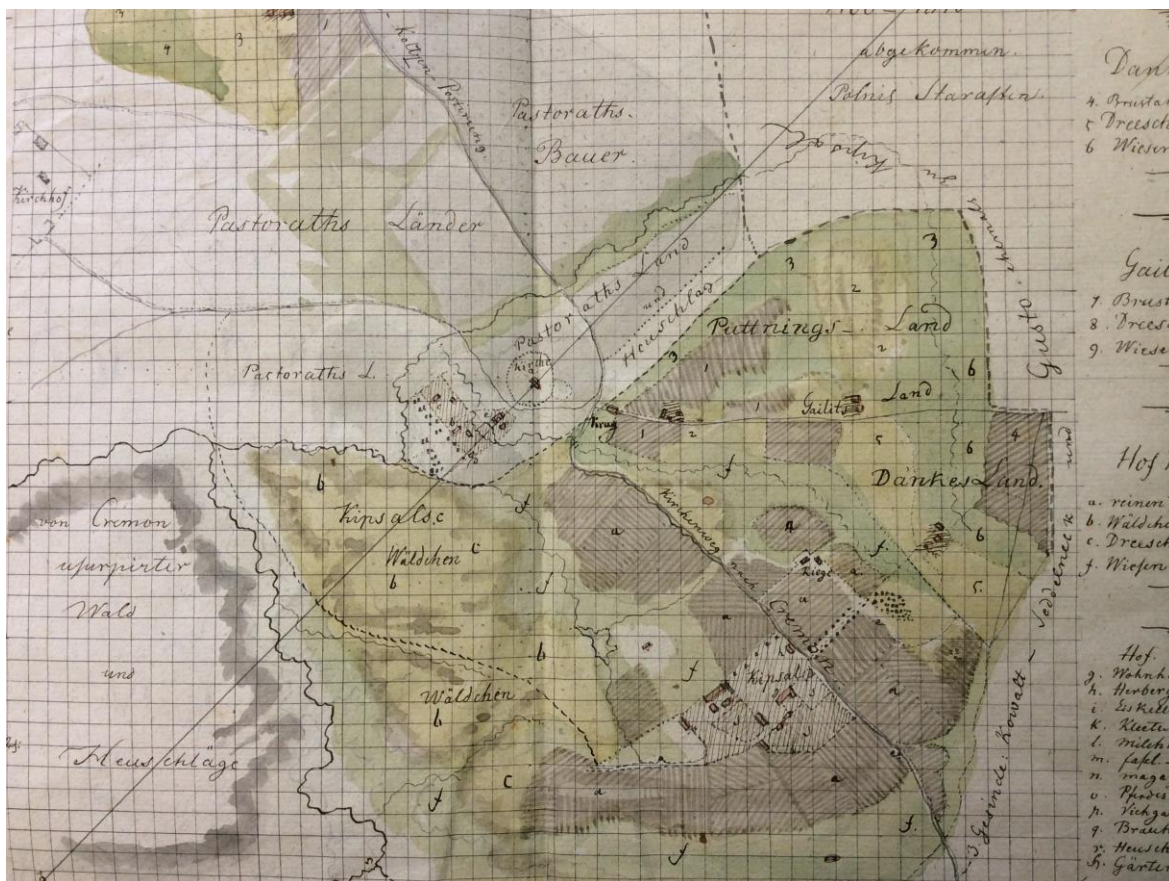
Fig. 5. Kizbele Manor and the layout of the parsonage situation. 1821. A drawing by J. V. Krause

The rectory building together with the church formed the scenic and planning structure of the surrounding area. It can be made sure by examining the situation plan drawn by J. V. Krause in 1821, where every building, road, forest and the fields, the more distant cemetery are detailed [13]. It can be seen that the present road from Turaida to Ragana directly approached the church, not passing by, as it is now. Walking across the brook, it as if encircles the church and further winds along its present location. The places of peasant farmsteads can be also seen in the plan, such as *Puttning*,

Wegge, *Gailit*, *Danke*. Some of these place names have survived to our days, such as Putniņi and Veģi. According to the plan, it can be learned that there was a barn, out-house, horse stable, and cattle-shed in the parsonage. In turn, the building of Kizbele (*Kipsal*) Manor consisted of the landlord's house, out-house, ice cellar, granary, milk chamber, storehouse, horse stable, cattle-yard, brewery, barn, and garden. It should be noted that the situation layout is not drawn by a land surveyor, so it is rough but a significant cultural and historical reference.

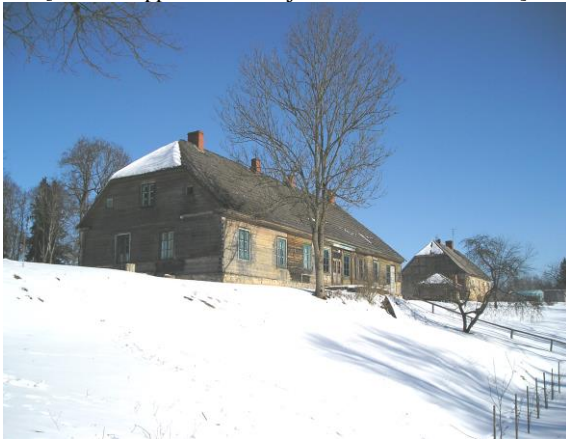
Fig. 7. The Krimulda pastorate
[Source: photo by author, 2010]

The rectory is located in the immediate vicinity of the church. The rectory is a distinctive sample of the wooden architecture of the Classicism period. According to the information available by the priest Jānis Ērmanis (1862–1932), it could be built by the initiative of the owner of Krimulda Manor – von Helmersen in 1775 [10]. The building is a log house with a steeped pitched roof, the ends of which are partially oblique. Two porches can be seen in one longitudinal facade near the entrance, in the other one a portico was located. Originally, there was only one porch - verandah on the right side [11]. The construction form of the building is traditional, gently rounded, rather unwieldy. The old classical door sashes were valuable monuments of art (the first half of the 19th century) which have now

been replaced by new, similar ones. In 1980, thanks to the activities of Kaspars Dimiteris, the pastorate experienced a revival. In 1912, the pastor J. Ērmanis opened a library there with 262 volumes. Through offering valuable books, its purpose was to combat corn trashy books. The library was devastated in 1917. In the context of the Krimulda congregation, *Cross School Book* written by the local teacher Juris Natanaēls Ramanis (1797) should be mentioned – a collection of various essays, the rebellious nature of which led to a conflict with the pastor [12]. A memorial stone set up in 1993 at the roadside opposite the church was devoted to him (the sculptor Vilnis Titāns). The servant (ringer's) house is located near the pastorate, the pediment of which is created in the fachwerk construction.

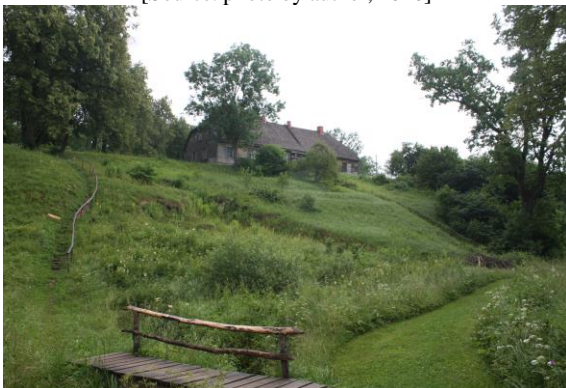
Fig. 8. The Krimulda pastorate
[Source: photo by author, 2016]

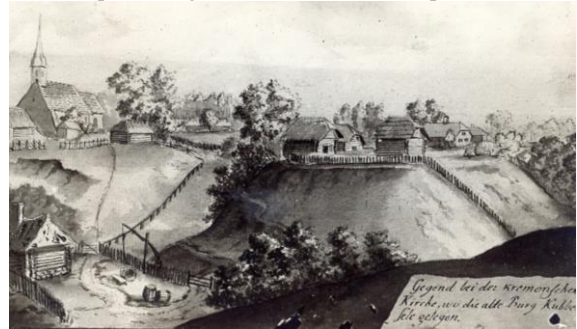
Fig. 14. The rectory and Krimulda Church
[Source: Johann Chistoph Brotze. Drawings and descriptions. Riga: Zinātne, 2002, Vol. 3, p. 166]

buildings are located: three log houses in the front are meant for household purposes, behind them to the right there is the pastorate but between the church and the pastorate, there is also a small house. Also, in front of the church and at the foot of the hill buildings are depicted. In the drawing, the hillfort is easily perceptible that cannot be said today – its slopes are more overgrown.
