Ķirbižu manor house: architecture and cultural history

Jānis Zilgalvis, *Riga Technical University*

Abstract. Ķirbiži manor house (Kürbis) is located in the Rural Territory of Vitrupe of the Municipality of Limbaži, less than ten kilometers away from the sea. Together with the lost Bisteri (Bisterwolde) estate, it is an ancient von Aderkas family estate which belonged to it over 400 years. Despite the various changes, the manor house and several outbuildings are still adorning the centre of the estate. There is also preserved the known as the landlord's new residential building and the park near the Vitrupe River. Unfortunately, there has been lost almost all the household complex and from 52 ever existing estate buildings there are left less than ten of them. The time tooth, people's neglect and economic decline have well enough impoverished this corner of Vidzeme. In 2006, there started revival of the remaining part of the estate. There was restored the cellar granary, reconstructed and restored the manor house, removed the stable, landscaped the park. During these works and before that, there was carried out the architectural – artistic and cultural – historical research.

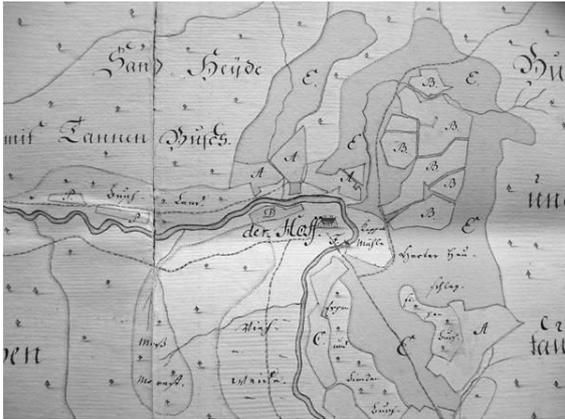
Fig. 1. A plan of Ķirbiži estate's land. The late 17th century, early 18th century [Source: Latvian State Historical Archives]

It should be noted that the new Bisteri estate location in Ķirbiži was not so far unknown since in the late 17th century-the early 18th century land plans, there is indicated a manor house (Fig. 1) with a mill at the Vitrupe River [4].

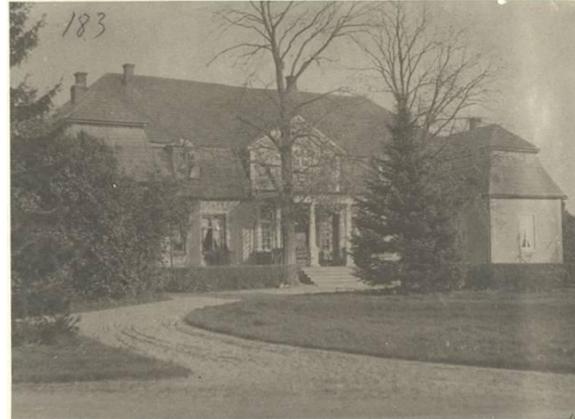
Fig. 2. Manor house of Ķirbiži estate (photo 1920) [Source: The State Inspection for Heritage Protection, Monument documentation centre]

So, the original manor house of Ķirbiži estate was a log house in the smooth corners of the house on a boulder stone socle floor. It was well proportioned, symmetric, covered with a mansard roof. The horizontal beams were covered by a 3.5 cm thick and 22 cm wide planking but from the inside they originally could be simply painted. At the building's front façade sides there were wings but in the center a mezzanine with a triangular pediment containing an oval window. In the center of the other longitudinal facade there was located a rizalite with a triangular pediment. At the main entrance, there was built a porch based on toscanic order columns. These graceful columns on high podiums with the facets decorated, existed even in March, 1952, as shown in a photograph from the Ķirbiži school materials – *Grade 7 girls organize a housekeeping afternoon for all the pupils*. The photo is now kept in the Limbaži Museum. The original porch solution is also seen for now in the oldest known photograph of the manor house as known from 1920 [7]. The photo might be taken after the foundation of the Monument Board in 1923 but the building's roof is made of shingles, in the main facade of the window openings it is with six windowpanes without the top leveling. It must be assumed that in 1920 it has been rephotographed from an earliest photo (Fig. 2).

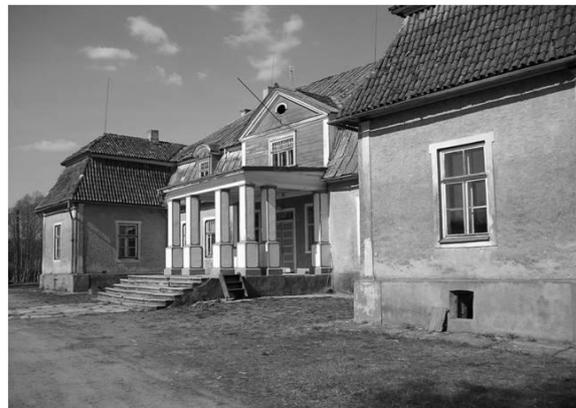
Fig. 3. Manor house of Ķirbiži estate before restoration (2006) [Source: photo by the author]

The podiums lost their own profiles over time and in 2004 they had already been reduced to a simple base on a little wider elevation (Fig. 3).

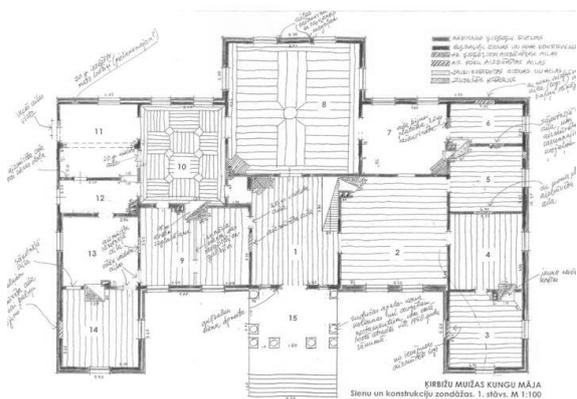
Fig. 4. The first floor layout of the manor house of Ķirbiži estate with probing and research results [Source: drawing by the author]

Layout of the manor house as a whole is traditional – in the hall or hallway which housed the stairs to the second floor symmetrically followed the Great Hall from which as it was generally accepted there was no way out to the park as in this side of the building there was basically no park but there could be a small garden. On both sides of the Great Hall in the anfilade followed rooms one by one. Also, from the hall or foyer the rooms on both sides were organized into the anfilade. As for the wings, the principle of the anfilade was not fully respected. The household entrance was located in the left end (Fig. 4).

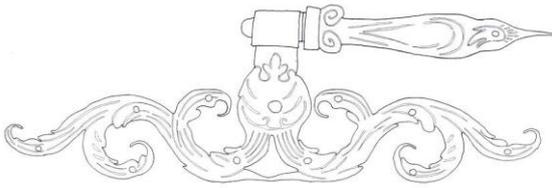
Fig. 5. Hinge of the internal door [Source: drawing by the author]

Both door panel surfaces are grooved but the top door panels between the grooves are with a fold. Between the two door panels there is an ornamental spiral ornament that somewhat resembles the spiral hook hinges of this door in the horizontal position. The already mentioned hook hinges and bolt of the door have survived to our days. The door that has survived to our days which dates back to the 18th century and shows that the door leaves over time have been changed, has metal parts. Unique door leaves from the 18th century have survived in one of the upstairs rooms. They are wide, four rectangular panel doors. Such panel division is rare and unusual. The leaves are hinged up in magnificent spiral hook hinges the surface of which is richly decorated. The artistic design of these hinges is very similar to the front door leaf hinges of the manor house but the details vary slightly as an individual blacksmith's work (Fig. 5).

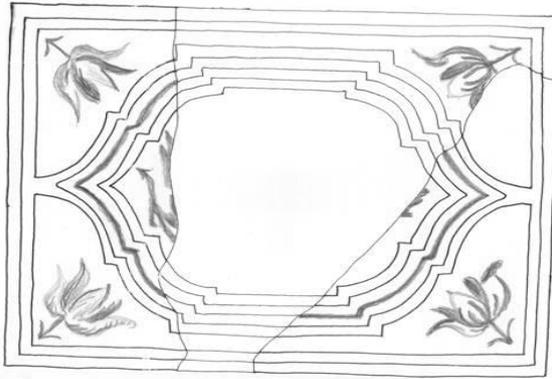
Fig. 6. An oven tile from the manor house of Ķirbiži estate. The first half of the 18th century [Source: drawing by the author]

During reconstruction and restoration of the manor house, there were found two parts of a tile, after which it may be concluded that in the first half of the 18th century, there was located an oven in the manor house, the tiles of which were decorated with a painting in the cobalt technique complementing the plastic decor (Fig. 6). In the center of the tile, there was a shape imitating embossed, baroque panels.

The paintings were in the corners of the panel (floral presentation), coloured was one of the panel profilings but in the center there is likely to have been a scene with some plot. It is not possible to tell what was depicted on other oven tiles glazed black with embossed ornaments and a storyline scene. This tile stove should be attributed to a later time – the second half of the 18th century.

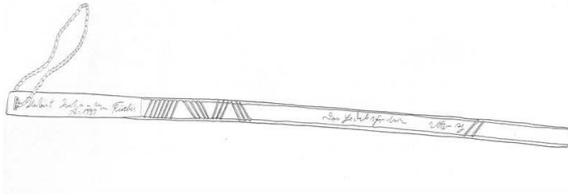
Fig. 7. A duty receipt. The mid-18th century
[Source: drawing by the author]

About the agricultural product duties to the estate in the 18th century tells an interesting find in the attic of the manor house. They were five wooden rods of different length the meaning of which at first even very erudite specialists were unable to explain. As it later turned out, they were the duty accounting *receipts*, dated with the years 1737, 1767 and later years. Their one end was made a little thinner to be able to write the name of the estate and the year on it. In one end of the rod, there was a hole with a string loop threaded in it in order to hang this item on the wall for the sake of the order. On the rod, the length of which was different—an average of 65 cm surface there were carved stripes with different slopes, crosses, etc. And for a non-knower it was associated with ornamentation. But each cut line, probably meant either cereals or flax or one of the other products. One such *receipt* was in the estate, the other with the peasant or fisherman's homestead owner who had paid his duties. Why wasn't it done in writing? It should be borne in mind that one part of the people did not know how to write and this kind of *documentation* was simpler. It took some time and the peculiar wooden *receipts* could be thrown away but the man of those times no longer needed these things but he didn't throw them out as simple as we are doing it today. They were placed in the attic—who knows, maybe, one day they will be useful—and forgotten by the time when during survey of the manor house they again saw the light of day, this time as a unique things that tell the story of the life of the estate for nearly 250 years ago (Fig. 7).

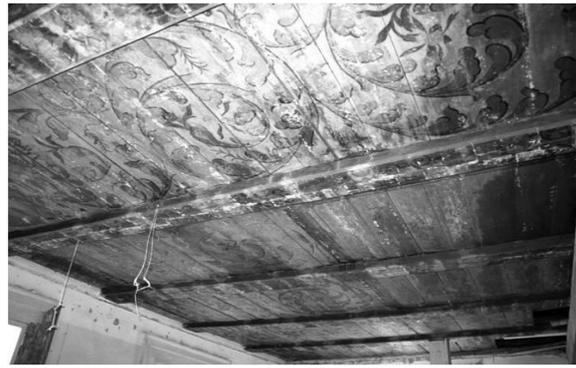
Fig. 8. ceiling paintings in the central room of the second floor.
The mid-18th century (2006) [Source: photo by the author]

The most valuable discovery in the interior there was in the room on the second floor when while removing the ceiling finish of a later time, there were revealed fantastic mid-18th century ceiling paintings which comparatively to other places were in a pretty good condition. The ceiling plane of the room was divided in six parts by open cover beams. In the middle of the ceiling, on both sides of the middle symmetric beam, there was highlighted a square shaped, profiled cornice imitative a baroque square where the decorative composition of the cross beam was different. What was in this square which exposing the ceiling was tinted in a red-brown shade is not known. The ceiling beams were especially richly painted. A geometric ornament was changed by the achantus leaf twists, with rather naive spirals trying to link all this in a single composition.

The boards placed between the beams were painted with spiral shaped ornamentation which in the ends were supplemented by twists of plant leaves (Fig. 8). These ornamentations were not the same everywhere, their painting solution was different.

In order to fill the space that was formed between the spiral paintings and the ceiling beams, there are used exotic bird depictions. It is the most incredible place in the ceiling murals. These birds are diverse and represented sitting on a twig or mound. Here we see a naive depiction of a pheasant, anyone else, it seems – a ravenous bird has taken in his beak an earthworm.

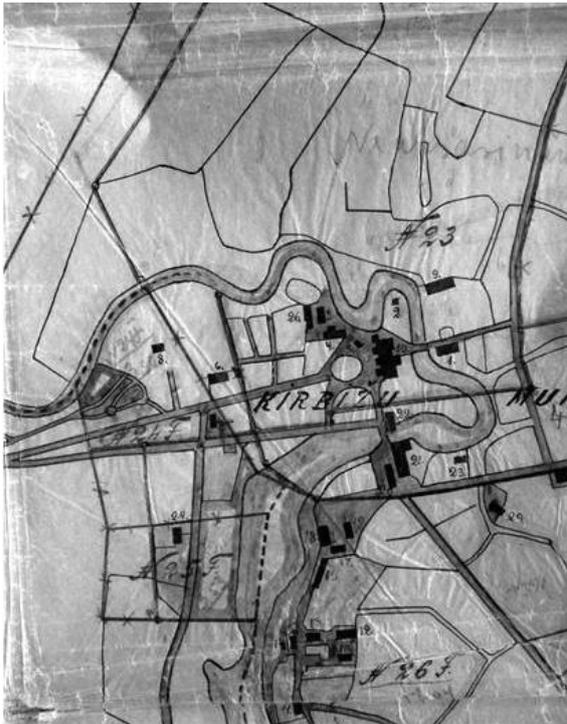
Fig. 9. Land division plan of the Ķirbiži estate (1920's)
[Source: Latvian State Historical Archives]

The restoration and reconstruction works of the manor house have been finalized. All the cultural and historical values as possible have been saved. The environment has been arranged and supplemented with new elements. Unfortunately, there is gone the housing situation which we can see in the land division plan of 1920's (Fig. 9).
