Burtnieki Rectory - a symbol of the cultural-historical environment unaltered through time

Jānis Zilgalvis, *Riga Technical University*

Keywords: architectural heritage, manor and sacral architecture, monument protection.

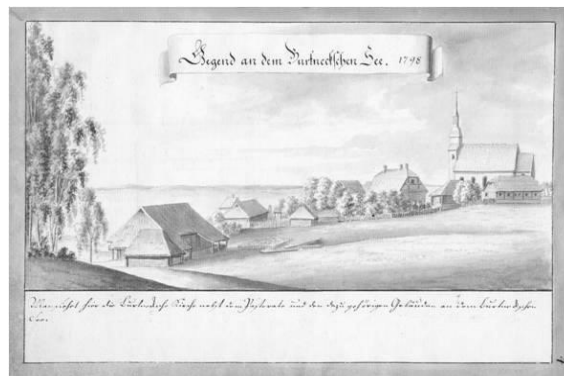
Fig. 1. The Burtnieki pastorate
[Source: Johann Christoph Brotze. Drawings and descriptions. - Riga, Science, 2002, p. 411].

rectory were depicted by J. K. Brotze himself [6]. In this drawing, it is easier to talk about the building of the rectory. In total, nine larger or smaller buildings are depicted. One of them – the rectory with a fackwerk pediment. In the left corner, a threshing barn is depicted, opposite the church, supposedly, the confirmant and the servants' house. The building is surrounded by a wooden fence. The rectory was renewed after the damages of the storm in 1795 and after the fire around 1803, and also later on when the roof was repaired and other works were carried out.

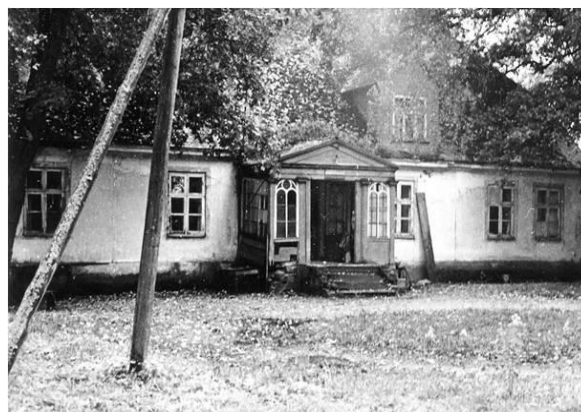
Fig. 4. The rectory [Source: State Inspection for Heritage Protection Republic of Latvia, Monument Documentation Centre, 1978].

Today, a one-storey building, covered with a steep gabled ridged roof, the ends of which are semi – tapered, gladden us with their grooming, the ancient unwieldy form, the historically accurate restoration of details. The building, built during the period of Classicism, is similar to its sisters – the

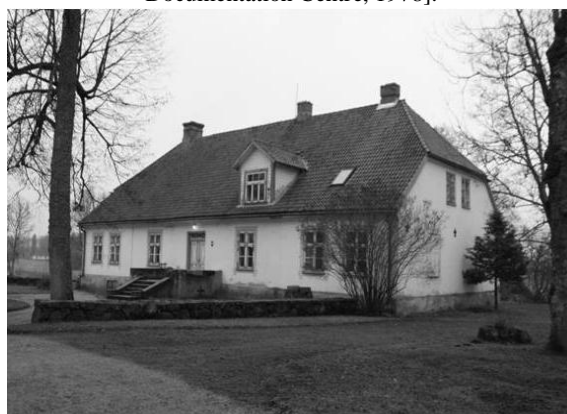
Fig. 5. The rectory from the backyard side [Source: photo by author, 2013].

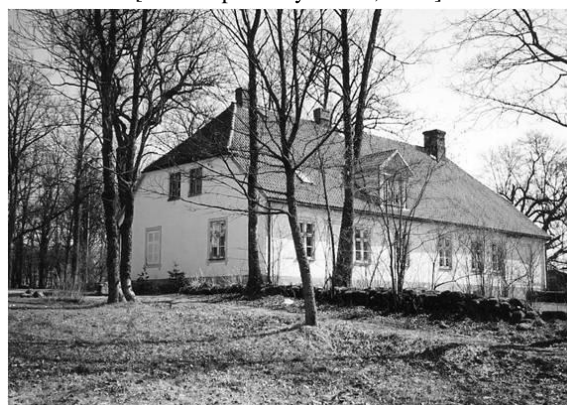
Fig. 6. The rectory from the lake side [Source: photo by author, 2008].

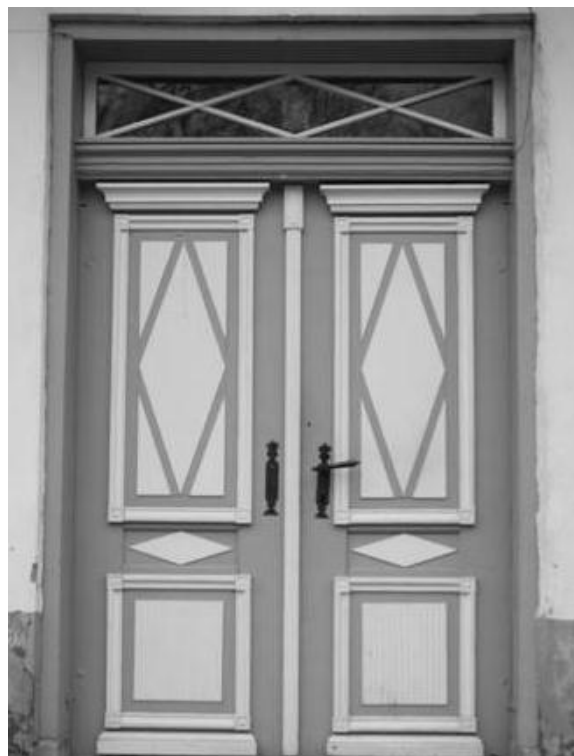
Fig. 7. The main entrance door leaves of the rectory
[Source: photo by author, 2013].

rectory in Dobele (*Doblen*), Limbaži (*Lemsal*), Āraiši (*Arrasch*), Ēvele (*Wohlfahrt*) and many other places. The main entrance door leaf stands out with a high artistic performance (around 1820). The leaf is divided into two panels. The upper surface is decorated with a diamond-shaped decor, the bottom – a grooved surface. Both corners of the panels are accented by a square element – a joinery decor characteristic of the period of Classicism. Also, the space between the two panels is

highlighted with a diamond accent. The window frame over the door is also diamond-shaped. The front door leaf lock is also an interesting historical testimony, which, together with the box lock dates back to the 18th century. This beautiful door leaves were restored in 2007 (restorer Inese Andersone). In the 1970s, the door leaves were hidden by a wooden porch with Neo-Renaissance style shaped windows, which probably was built in the second half of the 19th century, but later was demolished. This porch can be seen in several photographs dating back to 1929 and in the illustrative materials of a later time in 1978 [20].

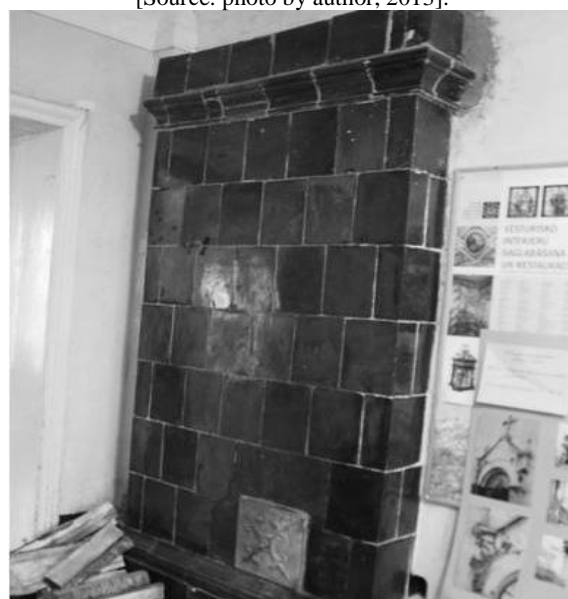
Fig. 9. A furnace in the hall
[Source: photo by author, 2013].

The staircase with silhouette-carved railing has survived in the entrance hall, which is built in 1843. A dark brown coloured glazed furnace with profiled eaves and plinth can also be seen there. In many places in Riga, it can be attributed to *Celms and Bēms /Zelm&Boehm/*. From the hall to the left, renovated two-panel door leaves lead to the pastor's office with an interesting furnace dating back to the end of the 18th century when the pots are painted. They have survived in the design of the eaves and the bottom of the furnace. Antique vases are depicted on a white background in a blue tone, but eaves – also with fancy motifs. In the middle of the furnace, the original tiles have been lost over time and replaced by white-glazed tiles. It is possible that these furnace tiles come from the old, wooden rectory, since on June 20, 1819, a meeting of the Convent decides that from the old rectory only furnaces will be used [15]. In front of the hall, there is a small room, in the corner of which a furnace has survived with a profiled eave and a niche in the middle. From this room, a door to the right leads into a larger prayer room, which also has an altar. This room is heated by a corner furnace with pilasters and a richly profiled eave (the mid-19th century). The other staircase can be seen in the kitchen end and the railing is with Baroque silhouette-carvings. Just as the mentioned staircase, it is made in 1843. At the foot of the staircase, a massive simple furnace is built, the bottom of which is extended. Interesting testimonies have also remained in the guest room behind the secretariat. On the end wall, once there were two built-in cabinets, built over in the course of time. During restoration of the building, they are recovered and now they serve as a niche with bookshelves. A furnace with profiled eaves and a distinctly elongated niche in the middle are located in this room.

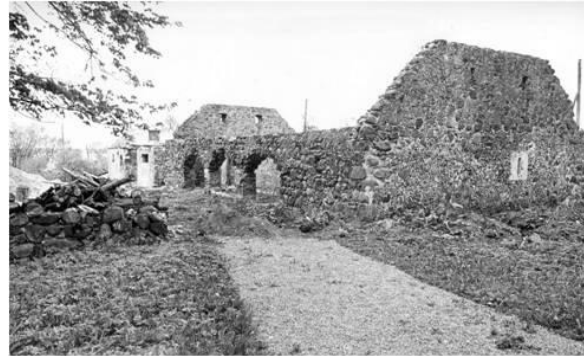
Fig. 10. The barn and the stable
[Source: photo by A. Biedriņš, 1989].

As already mentioned, in the 1990s, revives not only the rectory, but also the stable and the barn. It is known about the stable that in 1714 logs are allotted for its building [1]. In the course of time, it is worn, and in 1790 it is decided to build a new stable from boulders, covered with a tiled roof. After four years – in 1794, the works are completed, but the roofing is of straw [20]. In the following years, the stable is repeatedly repaired. Over time it gets a very bad technical condition and as already mentioned, it is renovated during the rebirth of the pastorate. Today, the outer wall of the building bears renderings, the gabled ridged roof with semi-tapered ends is covered with chips, the main facade consists of a porch arcade: three arches with the middle one being wider.

The barn is situated next to the stable, which is believed to be built at the end of the 18th century or at the beginning of the 19th century. This stone building is also covered with a steep gabled ridged roof, the ends of which are semi-tapered. The main facade consists of a porch arcade - three arches of an equal width. The building's facade is not in stucco, the brick walls with tiny chipping imprints in mortar are exposed there. Initially, around the window openings and in the arcade, the red brick is hidden behind stucco bands, as shown in the photo-fixation of 1929 [20]. During the Soviet era, the building gradually goes to rack and ruin and what is left – can be seen in the photos of 1989 [21]. They are only the load-bearing walls, because the rest is dismantled as hopelessly worn out. During the restoration of the building, around the window openings, the plaster styled bands have survived, but the arcade yet exposes the red brick. Strange that the two buildings – the stable and the barn are located close to each other, as if the manor is in lack of space.

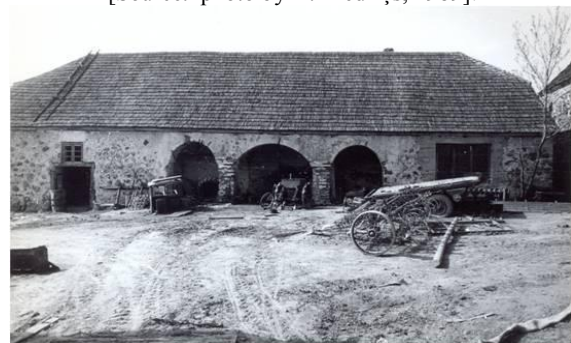
Fig. 11. The barn
[Source: State Inspection for Heritage Protection, Monuments Documentation Centre, 1967].

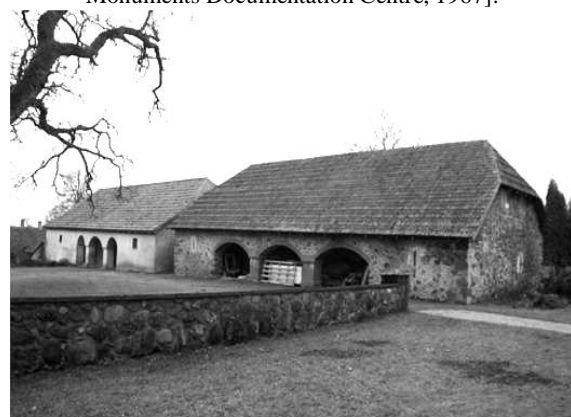
Fig. 12. The barn and the stable
[Source: photo by author, 2013].

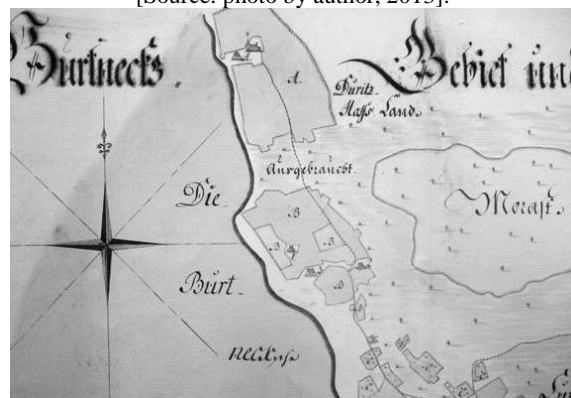
Fig. 13. The land map of Burtnieki Rectory.
1681., 1784 [Source: LVVA 7404., f., 1. apr., 496. 1].

Burtnieki Rectory and the land division plan of 1784 [16], the second one is the plan of the division of the land of the rectory during the Latvian agrarian reform [14], of a later time situation suggests the topographic plan of the 1970s and the 1: 200000 scale map of the Latvian roads from 1940 [12].

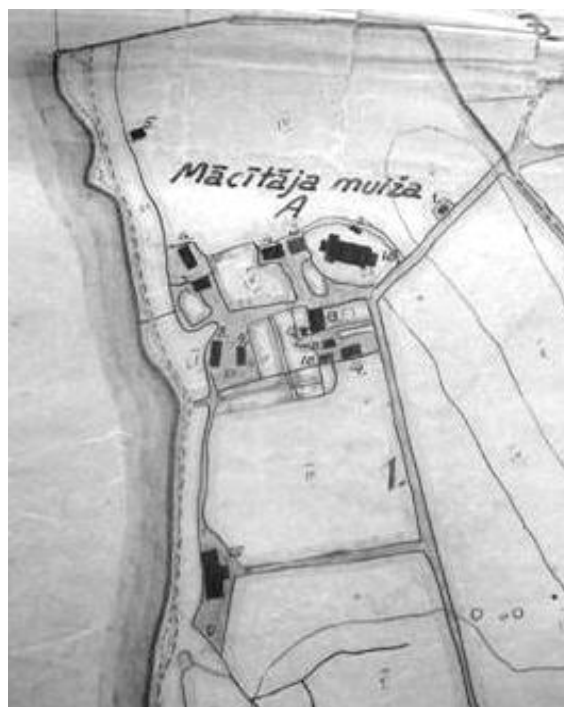
Fig. 14. The land division plan of Burtnieki Rectory [Source: LVVA 1679.f., 172. apr., 1841. l.].

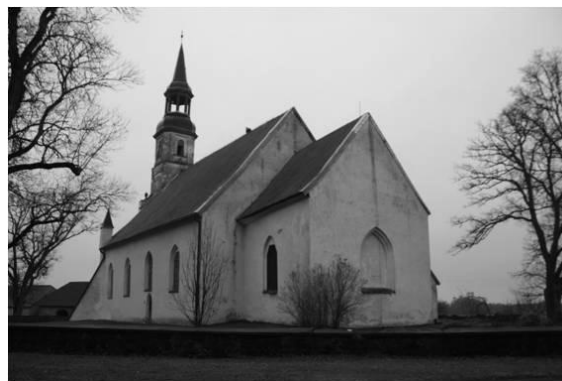
Fig. 17. The Lutheran Church of Burtnieki
[Source: photo by author, 2013].

On the bank of Burtnieki Lake, near the rectory house, the Lutheran Church of Burtnieki is located, the origin of which dates back to the 13th century, and, supposedly, it is built simultaneously with the castle of the order at Burtnieki during the period from 1283 to 1287. *The belonging of the building to the middle ages is represented by less than two meters thick walls of the congregation room. The oldest construction element is the Gothic window of the eastern wall of the altar part with four lancet arches* [11]. In 1654, the church is burnt down, and only the walls remain. The renovation of the building lasts longer due to the Russian-Polish war. The church with a tower in front of the main entrance is restored in the period from 1666 to 1669. In the period from 1683 to 1684, the renovation works of the building are carried out under the supervision of masonry master Michels Jungnikel from Riga.

and design of the facade of the ancient church is distinctly Gothic, but Baroque-style effects are shown by the tower's spike, finishing of the interior and the equipment as well. In 1962, the church was alienated to the congregation with the idea of having a concert hall there, but it was abandoned to the mercy of fate. Then, the equipment was vandalized, the interior partially perished. In 1981, the Church of Burtnieki initiated research work and from 1988 to 1993 it was followed by restoration works.
