## LIMIT DEFORMATIONS OF RETAINING WALLS IN LITHUANIAN HYDROSCHEMES

Aleksandras Stulginskis University, Institute of Hydraulic Construction Engineering

*In accordance with Standard STR 2.05.04:2003 all deformations of hydraulic structures are divided in two groups: 1) main – deformations of whole structure and 2) local – deformations of joints, supports, etc. Retaining walls of the used hydraulic structures are under the influence of climatic conditions, water, soil pressure and other types of loads. Deformations appear because of the aggressive environment and the load influence. The aim of the work is to evaluate the limit deformation of retaining walls on hydroschemes.*

*The state of 14 reinforced concrete retaining walls of hydroschemes was evaluated during the scientific expedition in the period 2007–2012. Retaining walls of hydraulic structures in Kaunas, Marijampolė, Kėdainiai, Panevėžys, Šilutė districts were examined and main deformations were determined.*

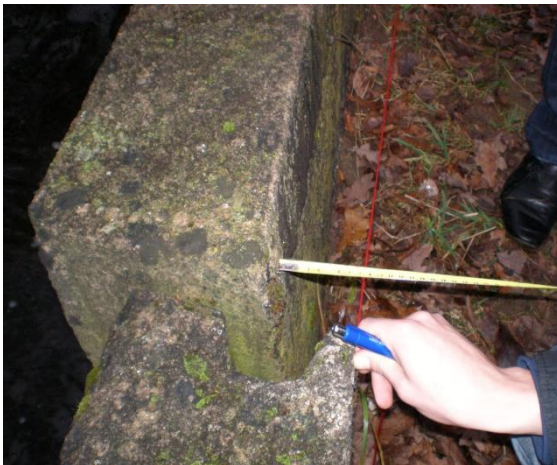
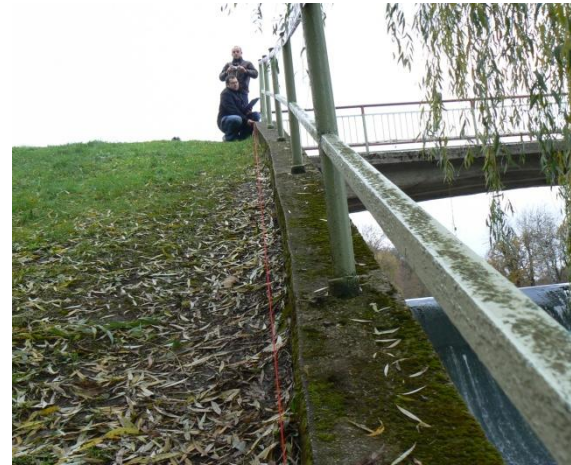
RW lengths, widths, heights, inclinations and deflections were measured during field observations (fig. 2).

**Figure. 2** Illustration of retaining walls deformations' measurements
