## **Reuse of Old State Buildings In Cabeceiras de Basto**

**Keywords:** state buildings, old primary schools, rangers' houses, railway station, rehabilitation, reuse.

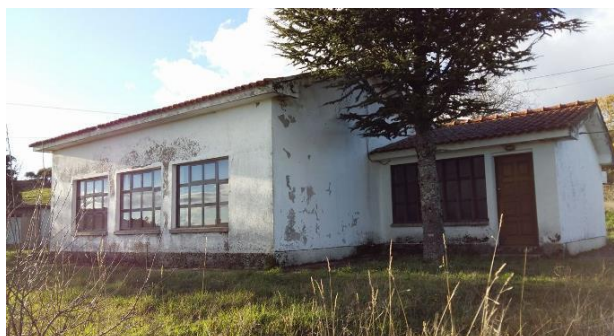
d) Toninha – Rio Douro

The old primary schools of the county of Cabeceiras de Basto are distributed by their various parishes, according to the needs they had at the time, in terms of population and/or students. There are twenty-eight former primary schools in this county. Only the primary school of Gondarém continues to be used as a school, Figure 2.a). The remainder are closed or were released to different types of entities, such as the Bucos' school, Figure 2.b). This old primary school reopened in 2012 as "Casa da Lã" (Wool House). In this case a deep intervention was required, taking into account the new functions attributed to the building. The Sta. Senhorinha - Basto primary school was also rehabilitated. Since 2017, Basto's Leisure Center, the Association of Friends of Basto and the Parish Council of Basto have been operating there, Fig. 2 c). Although, most of the schools assigned to institutions have been used after a small-scale rehabilitation or without any rehabilitation, as happened to the school of Toninha-Rio Douro, Figure 2.d).

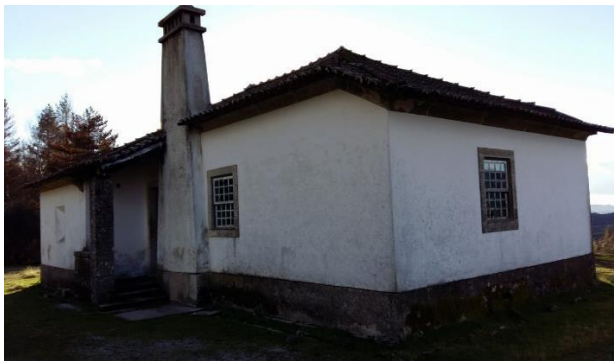
c) Magusteiro- Rio Douro

Nowadays, three different types of use can be observed for these houses. Four of them are still inhabited by former rangers and their families or only by their families, as for example the old rangers' house of Cambeses-Rio Douro, Figure 3 .a). Other four were rehabilitated for rural and tourist purposes by the City Hall, such as the house of Veiga-Bucos, Figure 3.b) [5]. And the remaining four are abandoned, the house of Magusteiro-Rio Douro, shown in Figure 3.c) is an example of this situation.
