THE COMPOSITIONAL SOLUTIONS OF THE HISTORICAL PARKS IN LATVIA

Aija Ziemeļniece

Latvia University of Agriculture

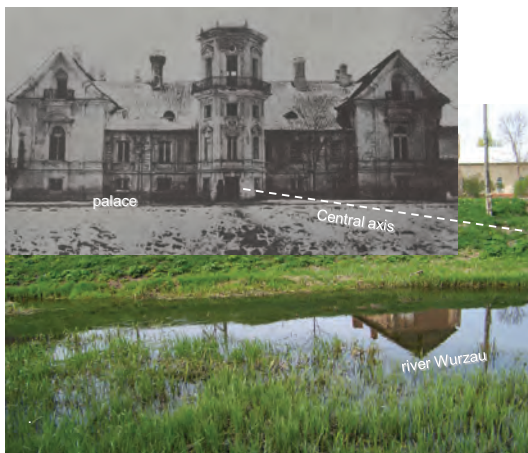
Figure 1. The location of the Vircava palace is restored at present park (author’s scheme).

The map drawn in 1779 by J. G. Schulz shows the compositional structure of the palace’s ensemble (Janelis, 2010), where the symmetry of the common structure of the ensemble is readable, consisting of the palace building and the baroque garden (Fig.1). The map shows the intersection of the two main axes: one

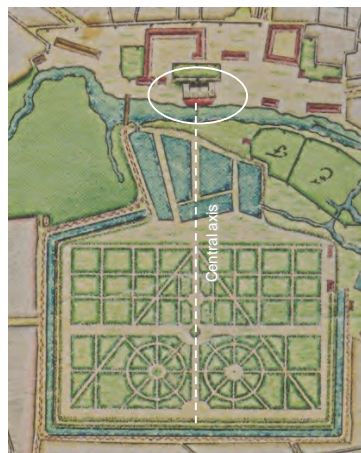
Figure 2. The central longitudinal axis as a view line across the river from Vircava palace to the (Janelis, 2010).

of them connects the palace and the park, where the expressiveness of the axis is intensified by a tree alley (Fig. 2). The second axis of the composition is the riverbed, as well as the linden transverse alley, which is perpendicular to the first one. The longitudinal axis and the intersection point of the river is a dominant, where the palace was positioned. The culmination was complemented by a tower built in the central part of the palace by S. Jensen, as well as the side blocks of the palace. The expressiveness of the park and the palace is intensified by the linden alley, without reaching 100 meters in length (Fig. 3). On both sides of it there are ponds, and the alley forms a kind of a green bridge, leading across the pond system. In the sight line from the palace through the alley, one of the five park ponds serves as a culmination. Behind it – a wide regular garden, which adds expression to the central axis. The other summer residence belonging to the Duchy – the Svēte palace, which is about 7 km away from the winter residence, located alongside the river Svēte, which is winding and rapid, and in springs and rainy

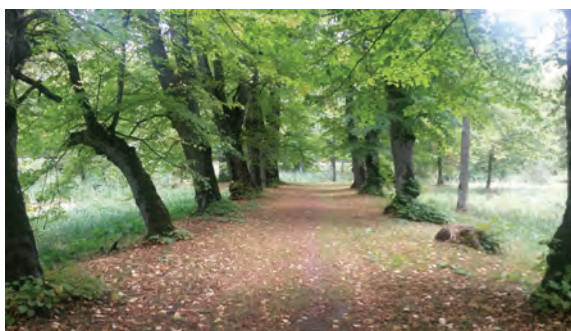
Figure 3. The historical tree alley on the longitudinal axis of palace Vircava (author’s photo, 2015).

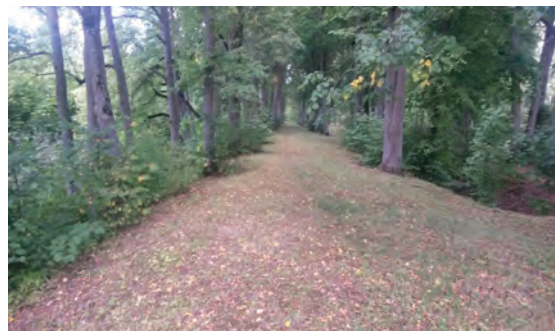
Figure 4. The alley with a rampart along the western side of the canal of parks Vircava (author’s photo, 2015).

The park around the perimeter was concluded by a ditch, the ground was piled inside of the park to create a rampart, dividing the park. Along the sides of the rampart, rows of trees were planted to form an alley with a walking path (Fig. 4). The Vircava neighborhood is typical of fertile clay soils that provide a good tree and shrub root development. In the park's western and northern sides, ramparts, the steep edges of the ditches, rows of tree plantations along the rampart and the walking path on the top of the rampart are well readable. On the opposite side of the ditch, on the west side of the park – the old highway and bridge (Fig. 5). It was the most direct way of communication between the Salgale and Vircava churches. From the old bridge site, a view opens along the river up to the floodplain meadows, in turn, from the bridge to the east - a view to the palace building ensemble and the river downstream. The sight line from the former bridge location marks the above mentioned compositional axis, which is parallel to the river. No matter how weird it would sound, but there has never been a bridge opposite the palace that would connect it to the park. The river Vircava close to the palace is as a unique parterre (Fig. 6). Today, the park's northwest part, like the entire park as a whole, has lost much of the historic tree plantings, the path network, the pond banks, creating a sports ground in this place. The southwestern part of the park is crossed by a road and a bridge. The road bed was built (1931) through the park's diagonal path location. Only

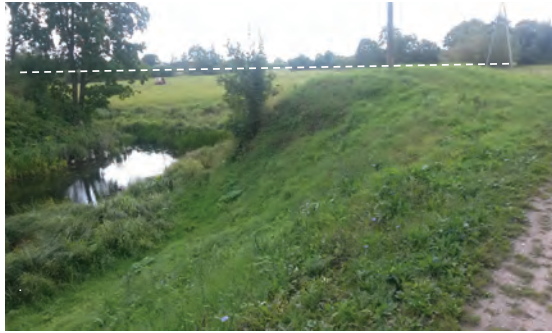
Figure 5. The location of the old Vircava bridge and the road (author's photo, 2015).

4. In the case of the reconstruction of the landscape space Vircava, it is possible to restore the historical bridge and the lost road bed that are now clearly readable in nature.

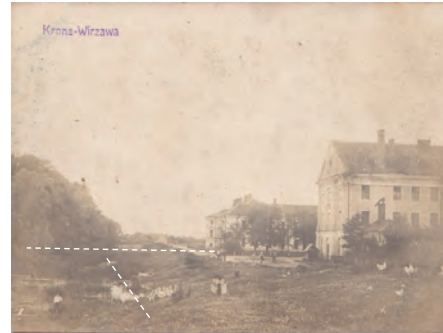
Figure 6. The intersection of two compositional axes: one axis – the Vircava palace and the park, the other axis – the riverbed (author's scheme).

By studying the spatial structure of the Vircava ensemble, it is concluded that its central axis had several depth plans, which formed an overall composition, counting from the northern part of the axis -

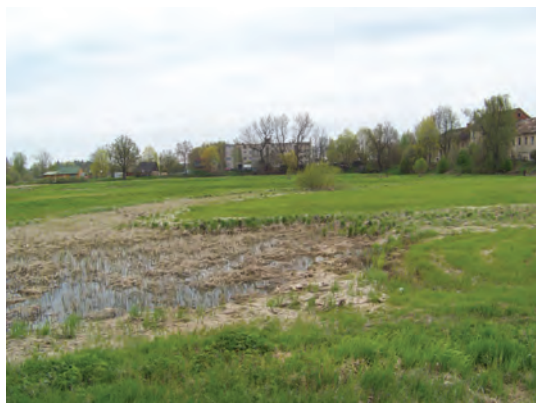
Figure 7. Sight line towards the location of the old road Svete (author's photo, 2012).

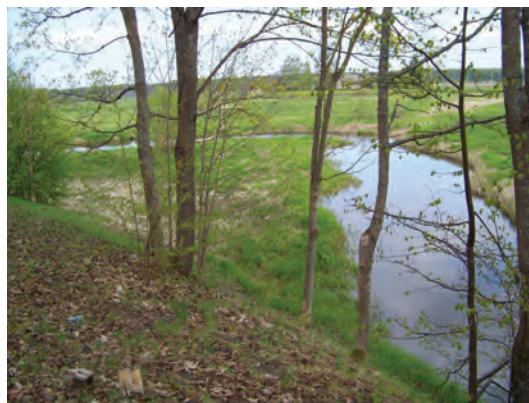
Figure 8. Stage bank of the Svēte river in front of the Svete palace. Taking away of the tree overgrowth in order to expose the distant sight lines (author's photo, 2012).

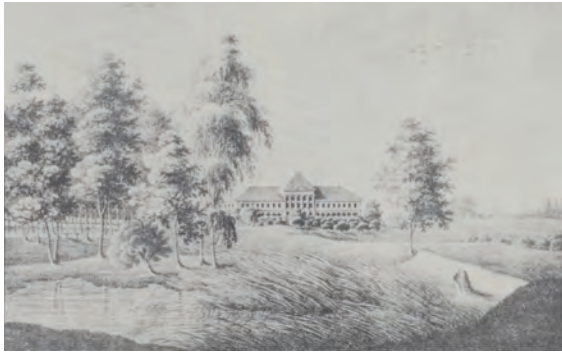
Figure 9. Svēte palace Gravure K.J.R. Mincelde
20th of the 19th century
(Rundale palace museum, 1991).

also have two compositional axis. The central axis or the main sight line from the driveway to the place is formed by the landscape space. It is like the foreground – in the view from the historic road in the northern part of the palace, which consists of a broad floodplain. The depth plan is concluded by the palace, which is well readable in the K. J. R. Minckelde's engraving (the beginning of the 19th century, Fig. 9). This broad sight line is preserved even today. The second axis connects the park part with the palace's longitudinal facade in the part of the inner courtyard, where the driveway to the palace is located. The connection of the parts of the park has been formed in the eastern part of the palace with its regular planning. Like the park of the Vircava palace, the Svēte park was also delimited by a ditch around the perimeter and a rampart with tree plantation lines, creating walking paths. Compared to Vircava, the delimiting ditch of the Svēte park is shallower and the rampart is more inclined. In the southeastern part, this axis winds in the direction of the Vircava palace, over the so-called Ruļļu kalni (Reel hills), where even today the old road through the Lapu krogs (Lapu pub) is apparent. In the beginning of the 20th century, from the palace's garden side the road had a linden alley (Janelis, 2010). The Swethof palace was built from 1774 to 1775 (architect S. Jensen). In 1799 – 1800, barracks and stables were built in the manor, but in 1875 the palace was rebuilt, completely destroying the interiors and facades (Fig. 10). A rough idea of the palace's park is given by the survey of 1876, showing a square four boskets created by cruciform alleys. J. Bernoulli, who saw the palace in 1778, wrote: "Near this amusement palace, there is ... a great, with waters rich garden which the Duke ordered to look more beautiful with pleasing English-style formations" (Rundale palace museum, 1991).). There was also a stone pavilion with 6 columns and a small gallery above the roof in the park.

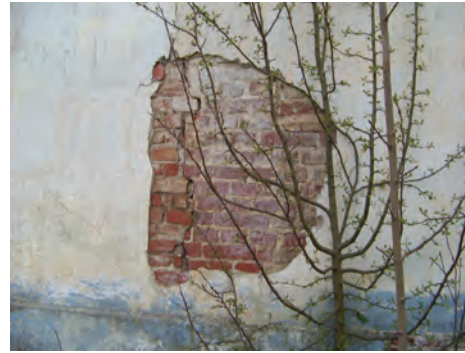
Figure 10. Places unclosed with walls of the
historical window of Svēte palace
(author's photo, 2004).

A serious transformation of the historical area of the Svēte palace dates back to the middle of the 19th century, when a new road between the palace and the park was built, as well as in the central part of the park horsemen cavalry barracks and stable buildings were built for the Imperial Army needs. The opulent conservatory was rebuilt, minimizing the window, door and floor height. This also applies to the central hall, which disappeared after the rebuilding. In the second part of the 19th century, solid long barracks were built in the courtyard side of the palace. The length of the perimetrally located building volumes is competing with the palace building. Their position is symmetrical against the palace and its courtyard, in the center creating the green area of a stretched form with a detour road. Following the above, it is apparent that the ensemble of the Svēte palace consists of three main compositional spaces – the floodplain grasslands in the northern part of the palace, the park in the southeastern part and the palace's courtyard in the west. Each of them has a different nature and scale of the construction. Here, another aspect should be mentioned. 1 km away from the park, the Vilce road is located in the southern direction, where in the far sight lines across the pasture, the park of the palace is readable, since the mentioned road is positioned in the terrain's elevation or the so-called neighborhood of the Ruļļu kalni with the level difference against the position of the palace - about 12 m. In the perception of the historical landscape space, it plays a big role. Over the centuries, with the transformation of the functional meaning of the buildings, the composition structure of the historical building is broken. The park's northern, eastern and southern side edge with the line of the historic trees. Part of the park has survived and may be renewed. In turn,

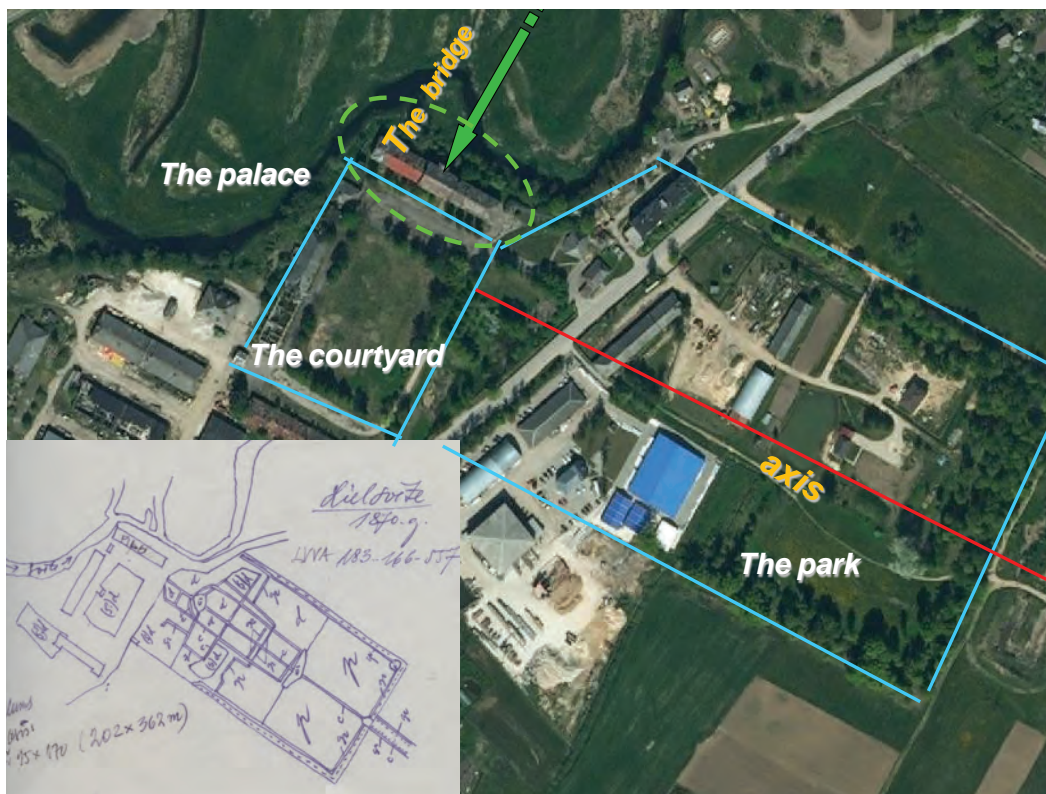
Figure 11. The comparison of the plan of the historic manor lands (1870) and today's situation (author's scheme, 2015).

- The end of the 18th century – the time of the construction of the palace and the park (architect S. Jensen);
- The mid-19th century – rebuilding of the palace for military needs;
- 60s of the 20th century – high-rise residential building;
- 90s of the 20th century – establishment of industrial areas;
- The beginning of the 21st century – privatization of the northeastern part of the park and building of a mansion.
